HISTORIC  
ENVIRONMENT  
SCOTLAND

## High Seas Fleet Salvage Sites Report

This report was compiled by ORCA Marine, University of the Highlands and Islands Archaeology Institute and SULA Diving on behalf of Historic Environment Scotland

9<sup>th</sup> January 2018

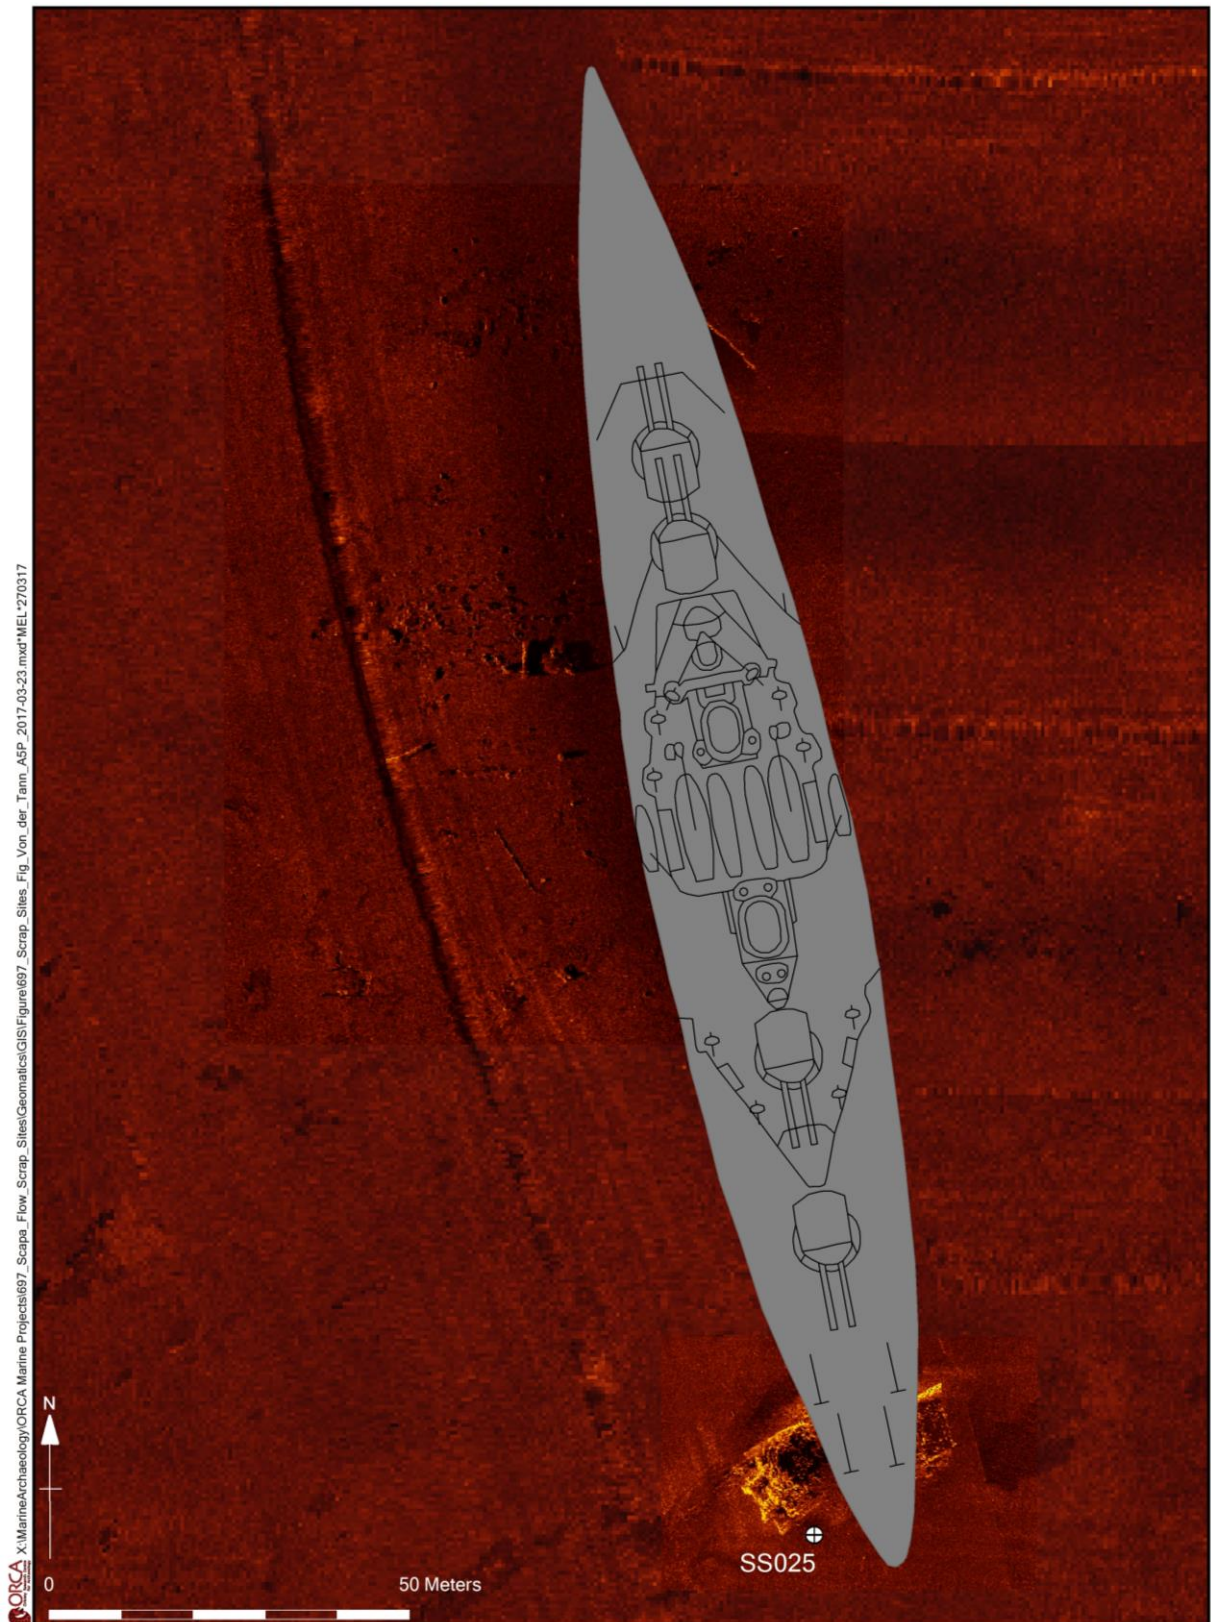
The side scan sonar survey of *Hindenburg* collected medium frequency data (325KHz) and focused high frequency data (780kHz). This provided an overview of the final scuttled location and salvage area of the battlecruiser. The survey identified anomalies associated with the salvage operations on the *Hindenburg*. Anomaly SS025 ([Figure 3](#), see Appendix 1) was identified as representative of the starboard and portside blocks used in the salvage operations.

Figure 3 Anomaly SS025 identified as the remains of the portside and starboard blocks used in Hindenburg salvage operations. This side scan sonar image has been overlain with an image showing the outline of SMS Hindenburg, as she would have sat between the destroyer sections. Wreckage material from the salvage operations on SMS Von der Tann is visible on either side of the northern half of the outline of Hindenburg.

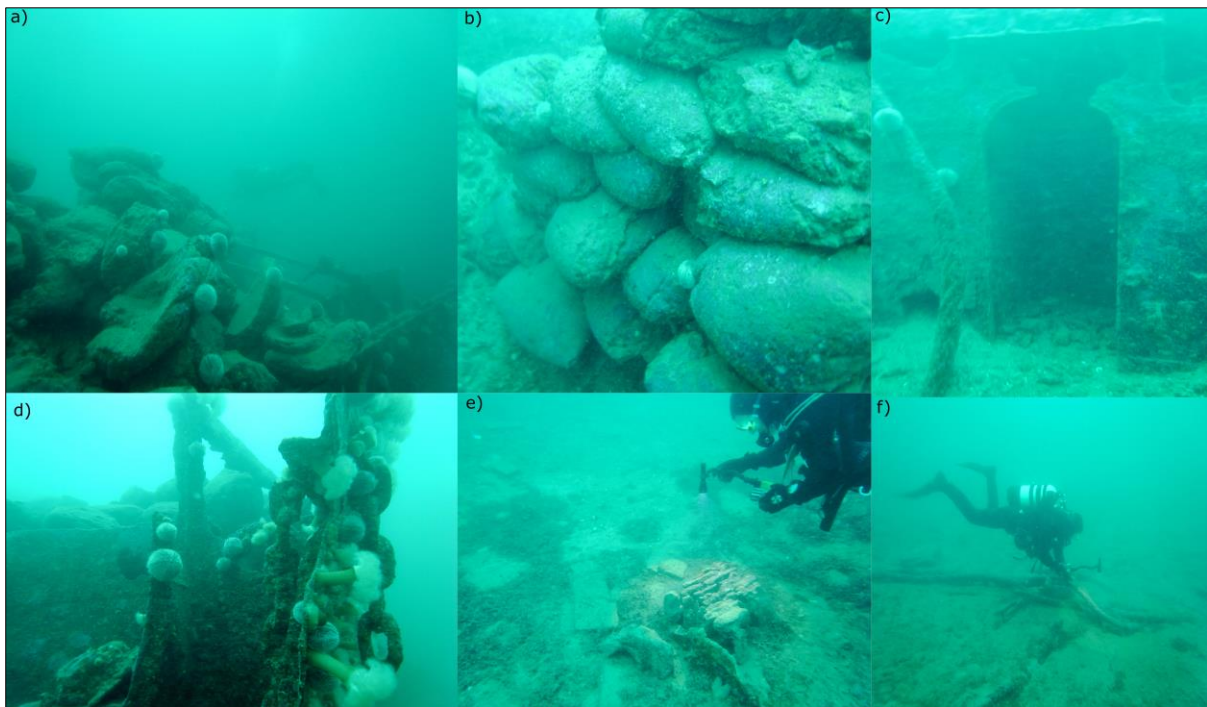
Diver survey focused on the two destroyer sections used as supporting blocks for the upright lifting operations. The two destroyer sections sit across the site SW to NE, they supported the *Hindenburg* at the stern as she sat upright on the seabed aligned NW to SE. The portside block was laid first due to her initially developing her list to portside, the starboard support was added before the final lifting operations. The diver survey began by investigating the starboard destroyer section. The sub-oval concrete sacks placed in the destroyers were clearly visible ([Plate 3a; 3b](#)), the saddle shape taken by the concrete is due to the load from overlying concrete bags and the imprint of the bags was visible on the blocks. Chains that were used to secure the concrete bags within the destroyer section were visible along the side of the destroyer section (The Dundee Courier 15<sup>th</sup> July 1930), and large quantities of lifting wire lay strewn on the seafloor ([Plate 3f](#)). The concrete bags located on the side of the destroyer sections where *Hindenburg* sat were broken down to rubble by her weight, forming heaps on the seafloor between the two destroyer sections.

Plate 3 a) Concrete bags in starboard destroyer b) concrete, imprint of the bag is visible on the concrete c) doorway portside destroyer d) cross section portside destroyer e) stacked corking lying to north of the portside destroyer f) lifting wire on the seafloor

The portside destroyer section ([Plate 3d](#)) contained a door at the SW end ([Plate 3c](#)), and large quantities of corking were scattered on the seafloor along with contained stacked cork sections ([Plate 3e](#)). This identification of the cork substantiates that it was a destroyer engine room section (George, 1973) used for the portside block, as corking was regularly used in engine rooms for insulation, although it was also used for this purpose in various locations around a vessel. Divers recorded deadlights on the seafloor approximately 75m north of SS025 ([Plate 4c](#)). A deadlight is a protective cover or shutter fitted over a porthole or window on a ship. The deadlights are most likely associated with the site of the *Hindenburg* as due to her upright position, the deadlights were removed and portholes were sealed off ([Plate 4b](#)).

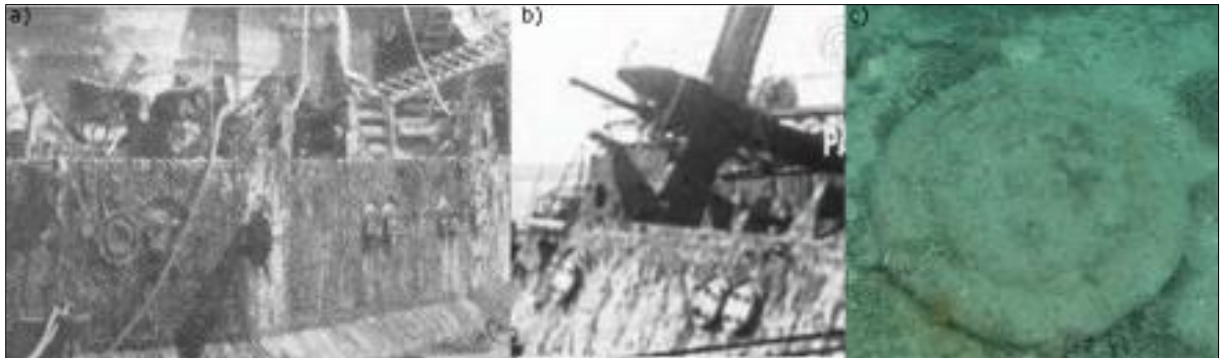
This is the only vessel recorded as having this practice happening, and the remains on the seafloor are likely from loss overboard. An enamel bathtub was located in the salvaged area that is similar in style to the bathtub found on the site of the *Dresden* (<http://www.scapaflowwrecks.com/wrecks/dresden/diving.php>).

Plate 4 a) Image showing *Hindenburg's* with deadlights b) After lifting *Hindenburg's* portholes can be seen to be blocked, with deadlights removed (British Pathe) c) Deadlights on the seafloor located north of SS025 at approx. 75m.

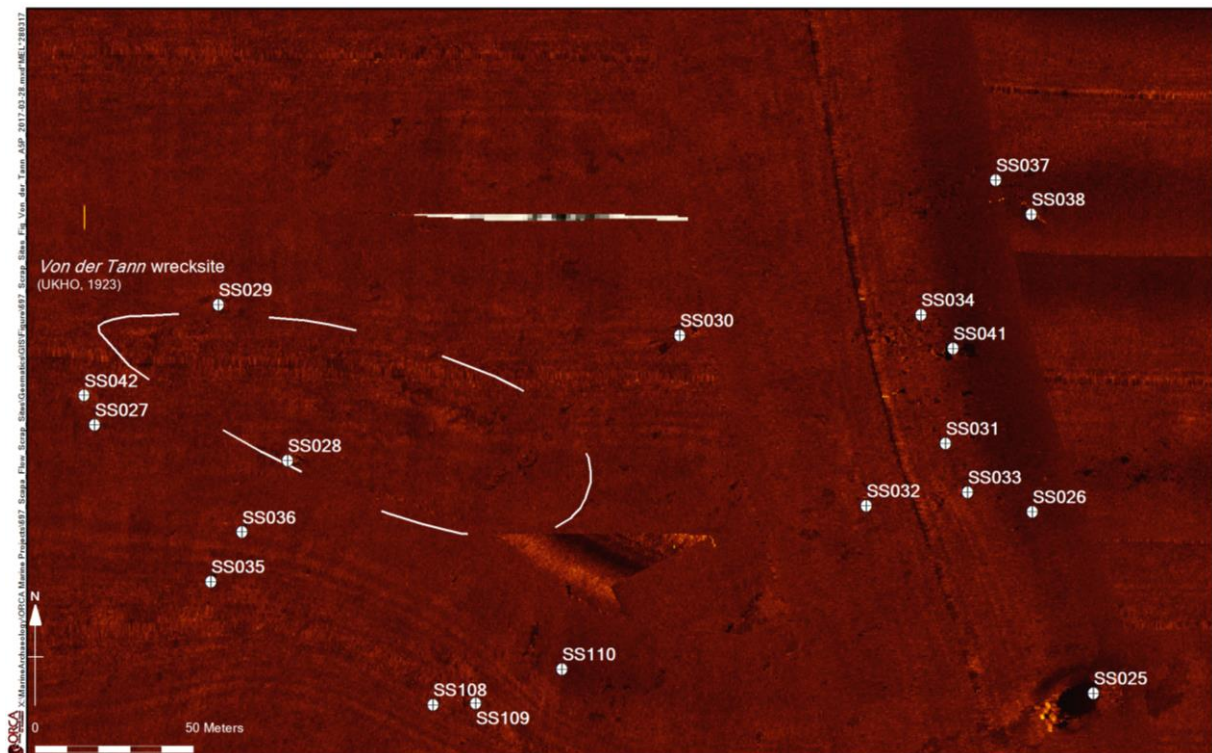
Figure 4 *Von der Tann* anomalies, charted outline of *Von der Tann* (UKHO, 1923)

Anomalies SS035; SS036; SS108; SS109; SS026; SS031; SS032; SS033; SS034; SS037; SS038 and SS041 are representative of the movement of the *Von der Tann* after towing into Cava took place ([Figure 4](#)) (see Appendix 1). The sonar survey results along with archival research indicated the extent of the *Von der Tann* material remains on the seabed, with direct evidence of the salvage operations and movement of the vessel once lifted.

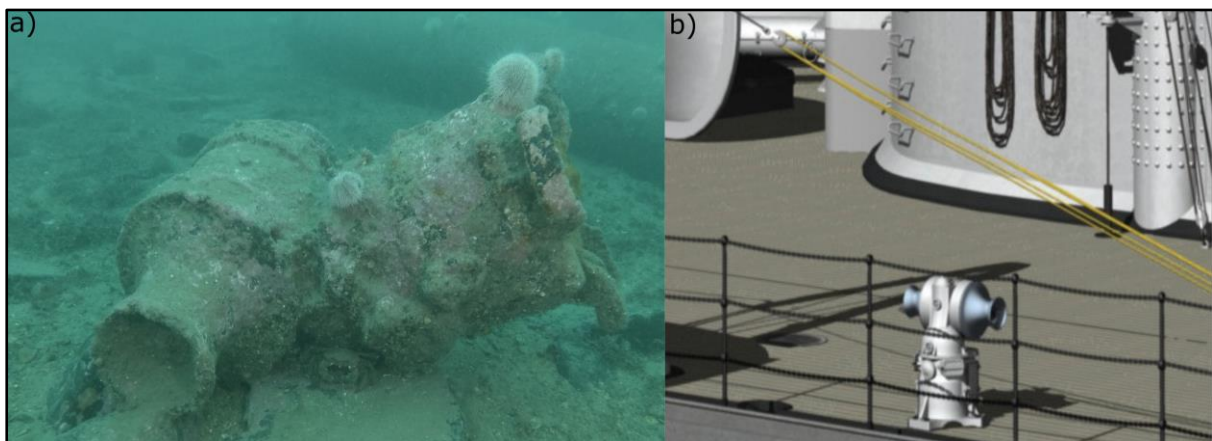
fitted each side of the upper deck on *Von der Tann* ([Plate 6](#)) (Friedman, 1992). The two rectangular boxes on this site are containers for sub calibre barrel liners; these were used for training to prevent wear on the gun barrels by firing a smaller round. Heavy wear on the ship's main armament when firing means that after approximately 150 rounds the gun liner needs replacement. This big operation involves returning the gun to the manufacturer. The use of these sub calibre gun liners would have been both time saving and cost effective. The rectangular containers had hatches at each end to facilitate cleaning of the barrel without removing it from the box. The two holes in the back of the gun turret were used to insert the sub calibre tubes. The holes line up exactly with the 28 cm gun barrels inside the turret. This type of rectangular sub calibre storage box is rare, and largely unknown as most were cylindrical in shape ([Plate 5a; 5c](#)) (*per com* Marsden Samuel).

Plate 6 a) coal winch on *Von der Tann* salvage site b) *Von der Tann* 3D model coal winch (Samuel, M., [sites.google.com/site/3dwarships/Home](https://sites.google.com/site/3dwarships/Home))

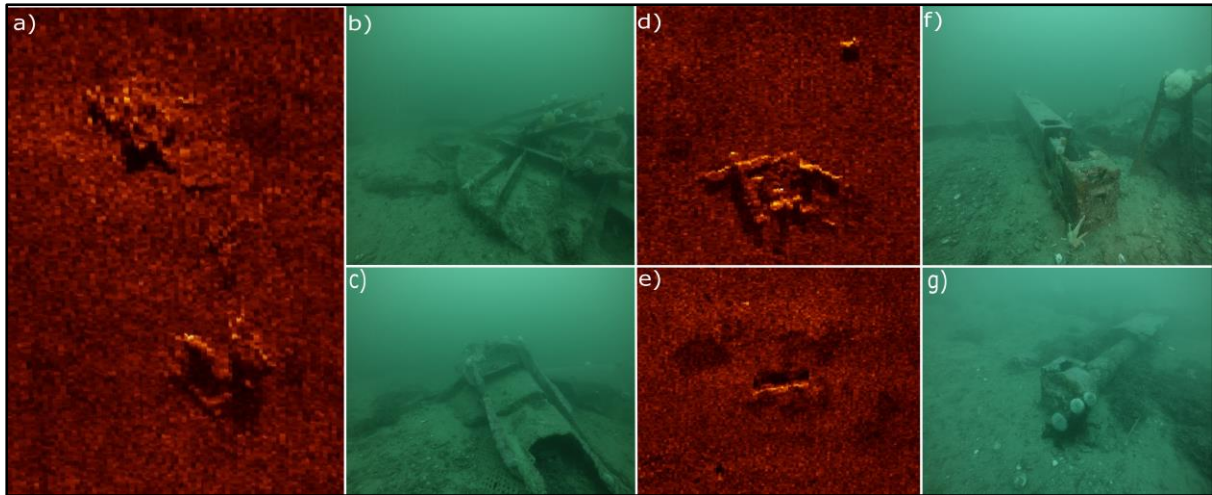
SS029 is a heavily built oval platform that is overlain with piping, bronze gearwheel and various objects. A sub calibre gun barrel liner in its rectangular storage box is located on this site along with an electrical metal box, and steel debris ([Plate 7e; 7g](#)), which is very heavy plating with riveted seams. Alongside this is a brass stand for a repeater compass but the compass is missing ([Plate 8](#)). A short distance away is a large steel door and a quantity of wood. SS042 is an upturned platform with steel girders and wires visible, a circular object with a handle is located underneath the platform, and a small object is located to the edge of the platform ([Plate 7a; 7b](#)). SS027 appears to be the bridge extension with lattice base ([Plate 7a; 7c](#)).

Plate 7 a) side scan sonar site image SS042, which sits to the north of SS027 b) SS042 upturned platform c) SS027 possible bridge extension d) SS028 side scan sonar site image e) SS029 side scan sonar site image f) SS028 platform with sub calibre barrel liner in rectangular storage box g) SS029 sub calibre barrel liner in rectangular storage box

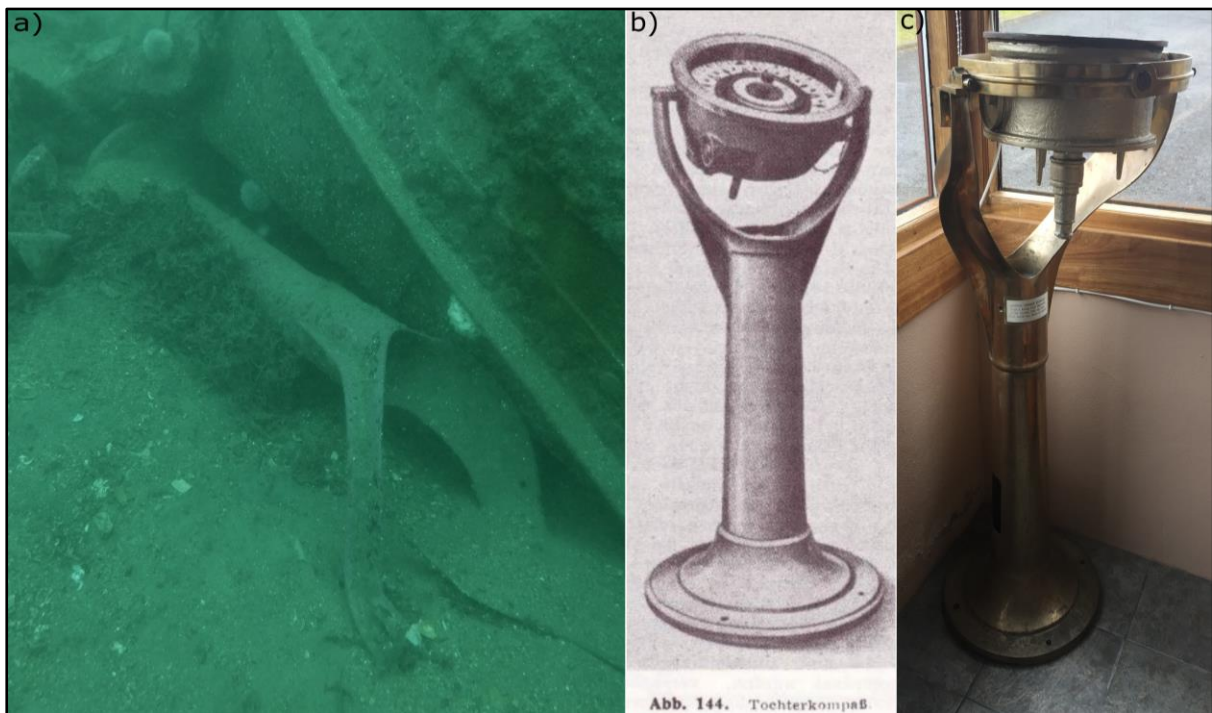
Plate 8 a) repeater compass found on site SS029, heavy riveted plating visible in background b) Image of German repeater compass c) repeater compass located in a coffee shop at Finstown, Orkney from the Grosser Kurfürst (source of origin unknown)

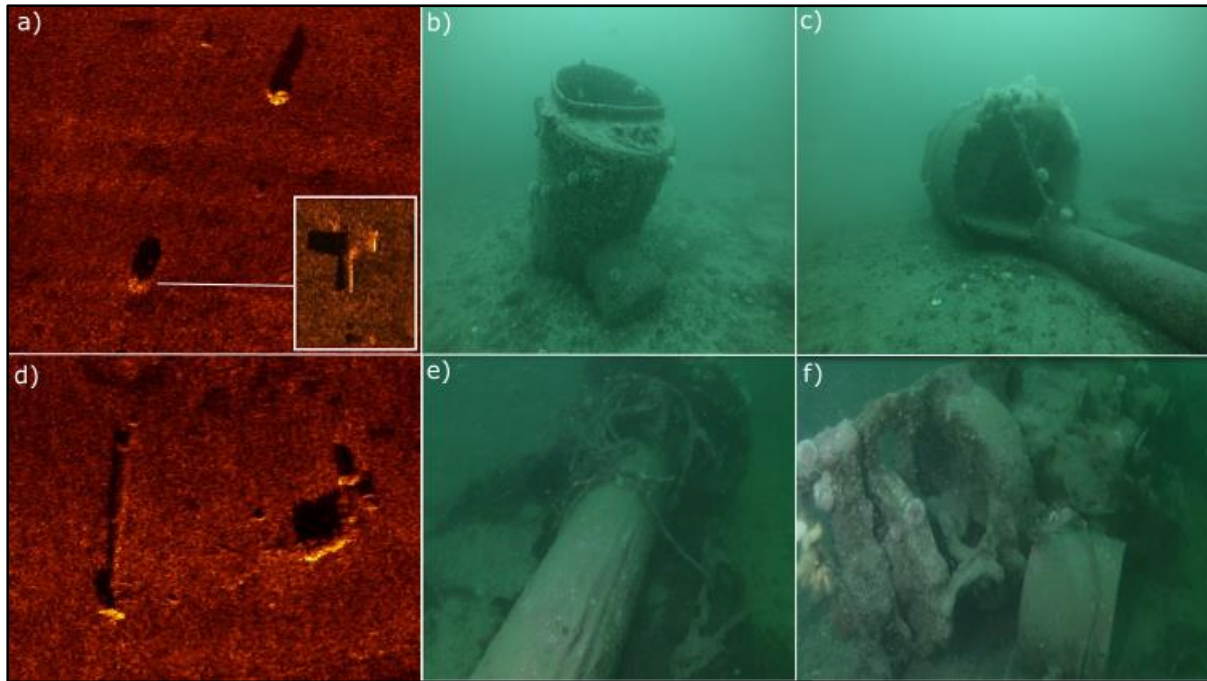
SS036 is a small pinnacle boiler standing on its funnel, with a brass valve located to its right when in normal position, on the underside and on the front inspection and cleaning hatches are located, and boiler grating is visible inside as the end has corroded. Mounting brackets are present on the side of the boiler ([Plate 9a; 9b](#)). SS035 is the upper forward mast section and spotting top of *Von der Tann* ([Plate 9a; 9c](#)). The top of the spotting top is heavily corroded, and a section on the seafloor still shows evidence of the viewing ports. Electrical cables are visible, with no evidence of attachments; there is a corroded hole in the base of the spotting top and a small pipe in the base along with various components on the floor. SS108 is probable

the lower forward mast section from the *Von der Tann* with a crow's nest identifiable by the bent handrails ([Plate 9d; 9e](#)). SS109 is a diesel pinnacle from the *Von der Tann*: the site contains a small engine, copper pipes and fittings ([Plate 9d; 9f](#)). The *Von der Tann*'s smaller motor boats were mounted on the middle two gun turret tops (*per com* Marsden Samuel).

Plate 9 a) side scan sonar image of SS036 and SS035 lying in close proximity on the seafloor, image inset of SS035 b) SS036 pinnacle boiler c) SS035 mast with spotting top d) side scan sonar image of SS108 and SS109 lying in close proximity on the seafloor e) SS108 lower mast section with crow's nest f) SS109 diesel pinnacle engine

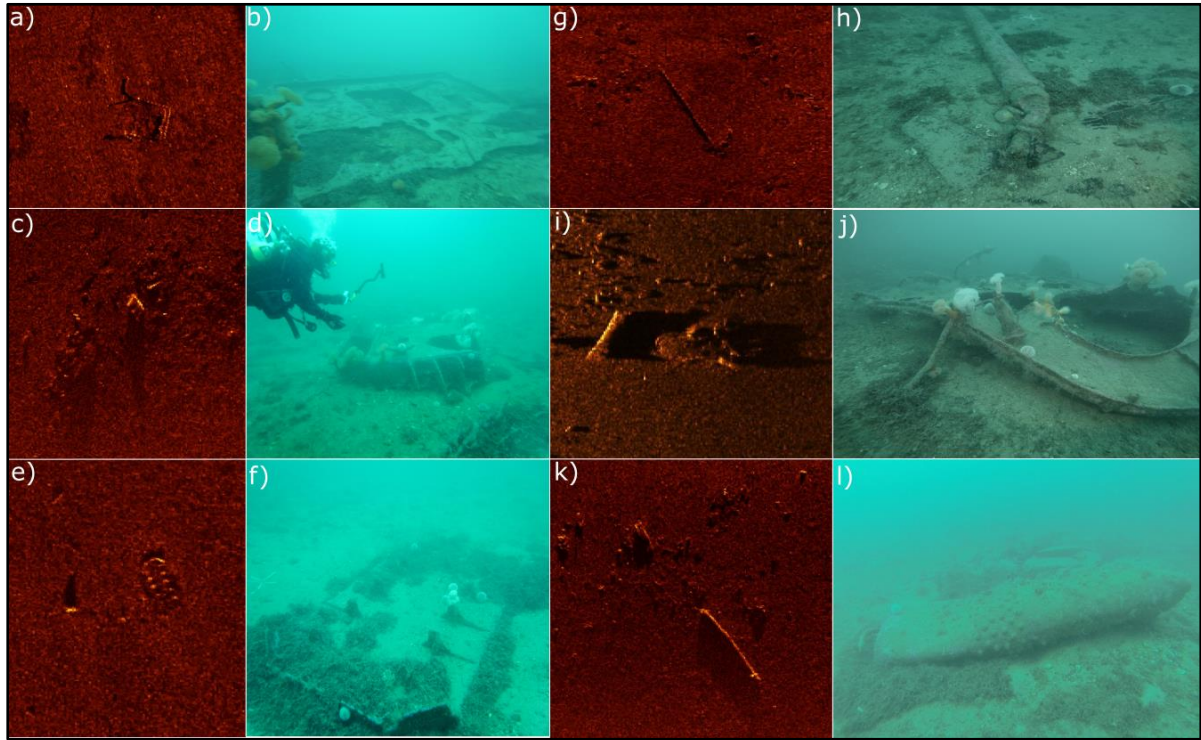
Diver survey ground-truthed the anomalies representative of *Von der Tann* movement overlying the scuttled site of *Hindenburg*. This survey focused on a debris field approximately 100m by 60m that showed the movement of the *Von der Tann* northeast. SS032 is a heavily corroded rectangular platform with two circular mounts visible that may represent the base of a searchlight platform or searchlight control platform ([Plate 10a; 10b](#)). SS033 is a rectangular box structure with cleats on its upper side, possibly part of a ventilation system ([Plate 10c; 10d](#)). SS026 is buried platform of sub oval shape with truncated corners, with the rim and strengthening elements of the platform protruding from the seabed ([Plate 10e; 10f](#)). SS031 is a davit spar with rigging still visible ([Plate 10f; 10g](#)). SS041 is a searchlight platform with the location of where the two searchlights were mounted identifiable as circular apertures alongside a larger circular hole for the mast showing evidence of stress damage and the entrance hatch to allow access to the platform ([Plate 11](#)). Evidence of boltholes for securing the searchlight is visible around the searchlight circular apertures. Cables and a search light base with rubber mounts are located next to the platform. The rubber mounts would protect the searchlight from shock damage when the main guns were fired, and it is one of two types of searchlight mounting systems noted on the various searchlight platform sites recorded during this project. No other evidence of the searchlight is present on the site ([Plate 10i; 10j](#)). The platform is the type present on *Von der Tann* and not the *Hindenburg* type, it was dragged and turned upright as the ship was pulled inshore. The platform shape indicates this is the aft searchlight platform ([Plate 11](#)). To the southwest of the searchlight

platform a second searchlight base with one rubber mount was located. A section of mast lies nearby. SS034 and SS041 are located within a boulder field, and within this area is a mast broken by impact rather than blasting, a coal winch and small anchor. To the west of this lies another section of mast raised off the seabed at its eastern end. SS038 is a derrick arm, with SS037 a heavily riveted samson post of the style found on the *Von der Tann* lying in close proximity ([Plate 5a](#); [5b](#); [Plate 10k](#); [10l](#)). Deadlights (as described above) most likely from the *Hindenburg* were noted in a number of locations throughout this debris field.

Plate 10 a) side scan sonar Image SS032 b) SS032 heavily corroded rectangular platform c) side scan sonar SS033 d) SS033 rectangular box with cleats e) side scan sonar Image SS026 f) SS026 partially buried platform g) side scan sonar Image SS031 h) SS031 davit arm i) side scan sonar Image SS034 & SS041 j) SS041 includes a searchlight platform and searchlight bases k) side scan sonar Image SS037 & SS038 f) SS038 riveted samson post (see [Plate 5](#))

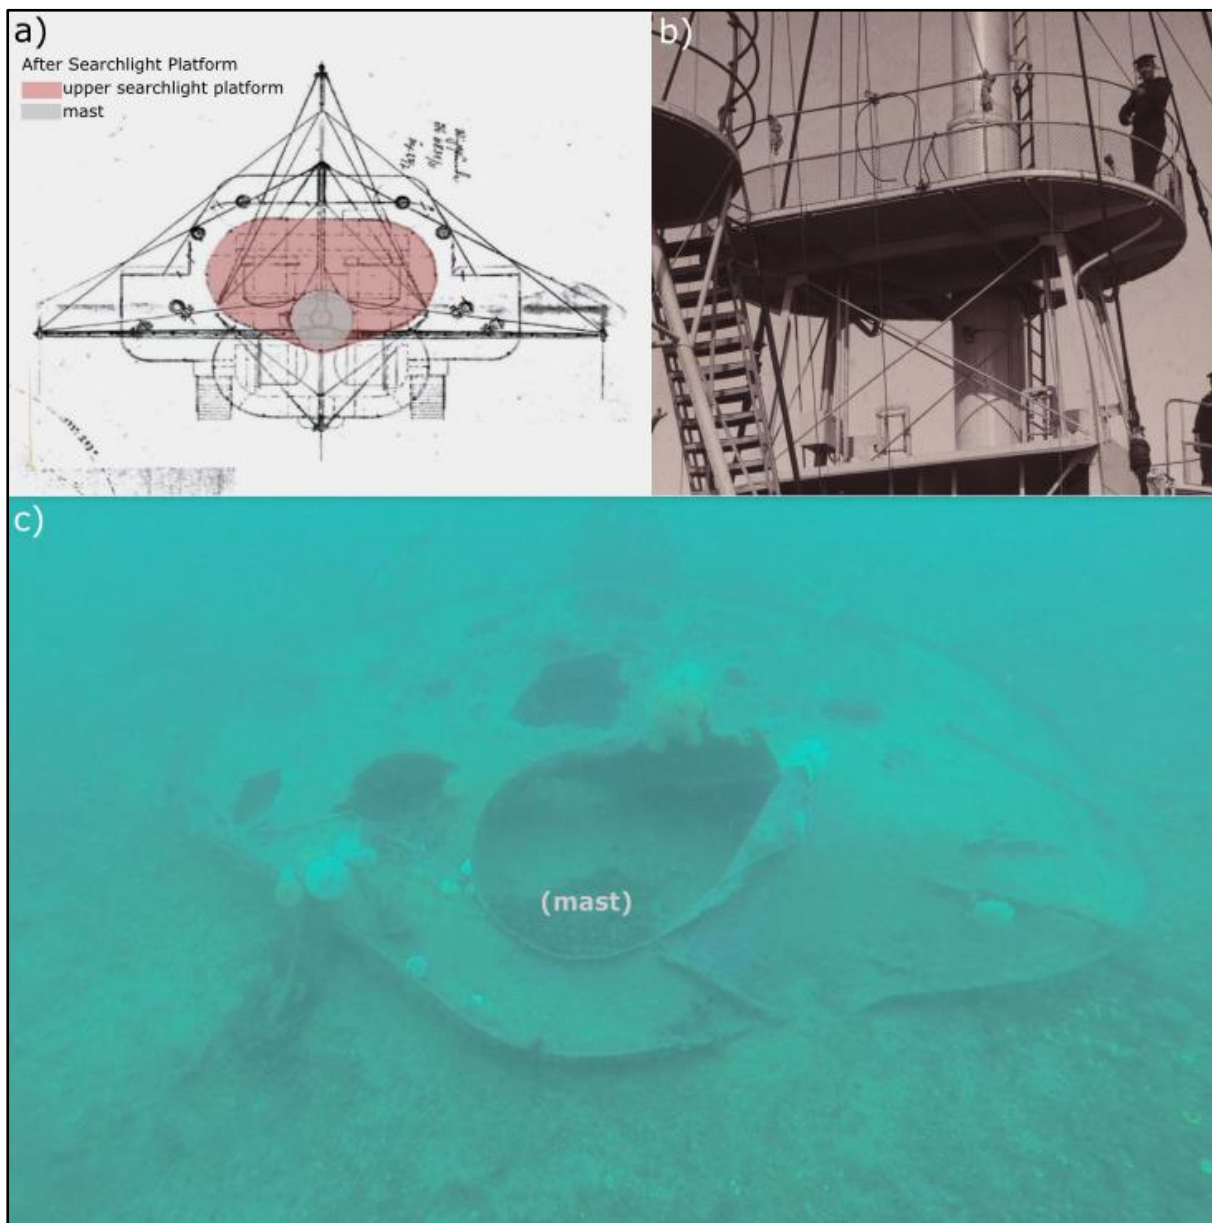
Plate 11 a) Von der Tann ship plan showing after searchlight platform plan view (courtesy Marsden Samuel) b) aft searchlight platform of the Von der Tann (courtesy Gary Staff) c) searchlight platform on the seafloor is the after upper searchlight platform

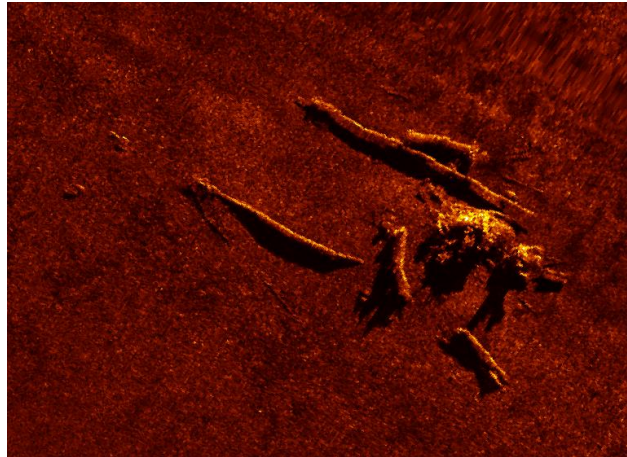
Anomalies identified off Rysa Little, the secondary location used by Metal Industries Ltd for the removal of superstructure, were assumed (see below) to have come from the *Grosser Kurfürst* (SS080).

Plate 12 SS080: Grosser Kurfürst superstructure located at Rysa Little secondary site

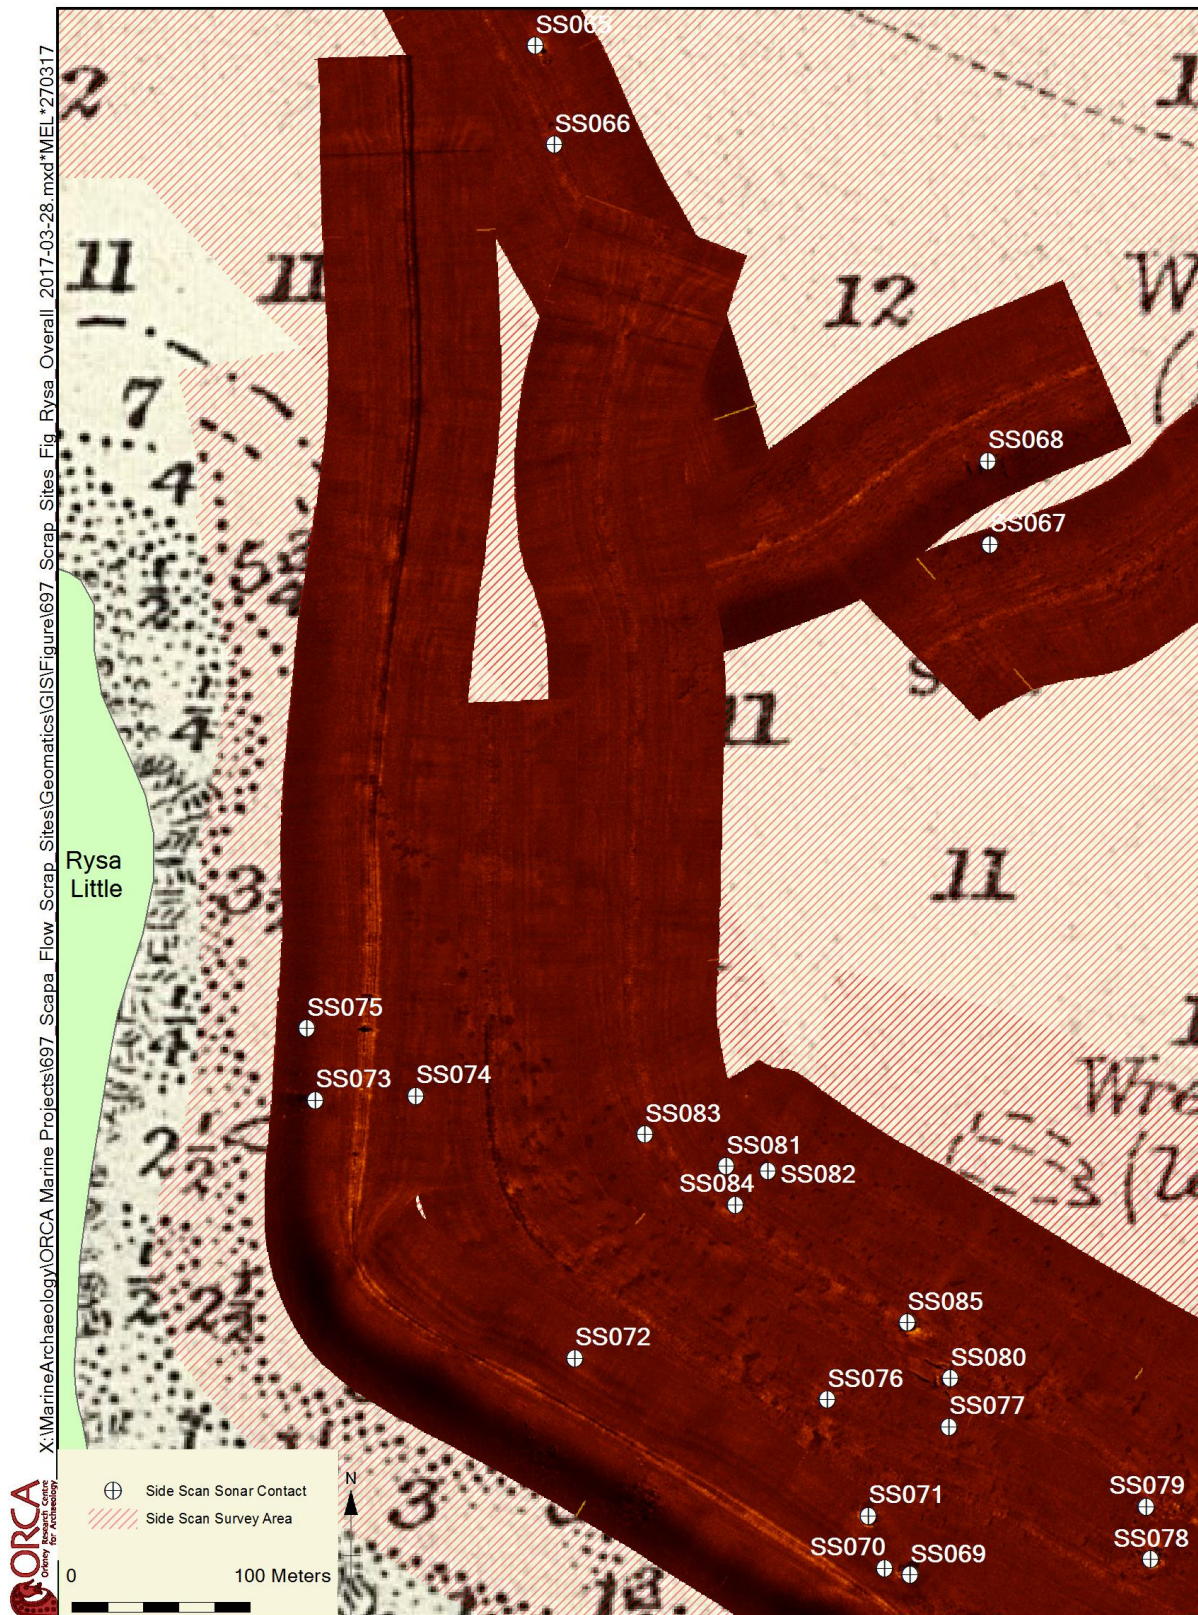
The side scan sonar survey of Rysa collected medium frequency data (325KHz) and focused high frequency data (780kHz). This provided an overview of the area. Anomalies SS065, SS066, SS067, SS068, SS069, SS070, SS071, SS072, SS073, SS074, SS075, SS076, SS077, SS078, SS079, SS080, SS081, SS082, SS083, SS084 and SS085 (see Appendix 1) were identified in the area of the salvage operations at Rysa.

Figure 10 Side Scan Sonar image of anomalies located at Rysa Little

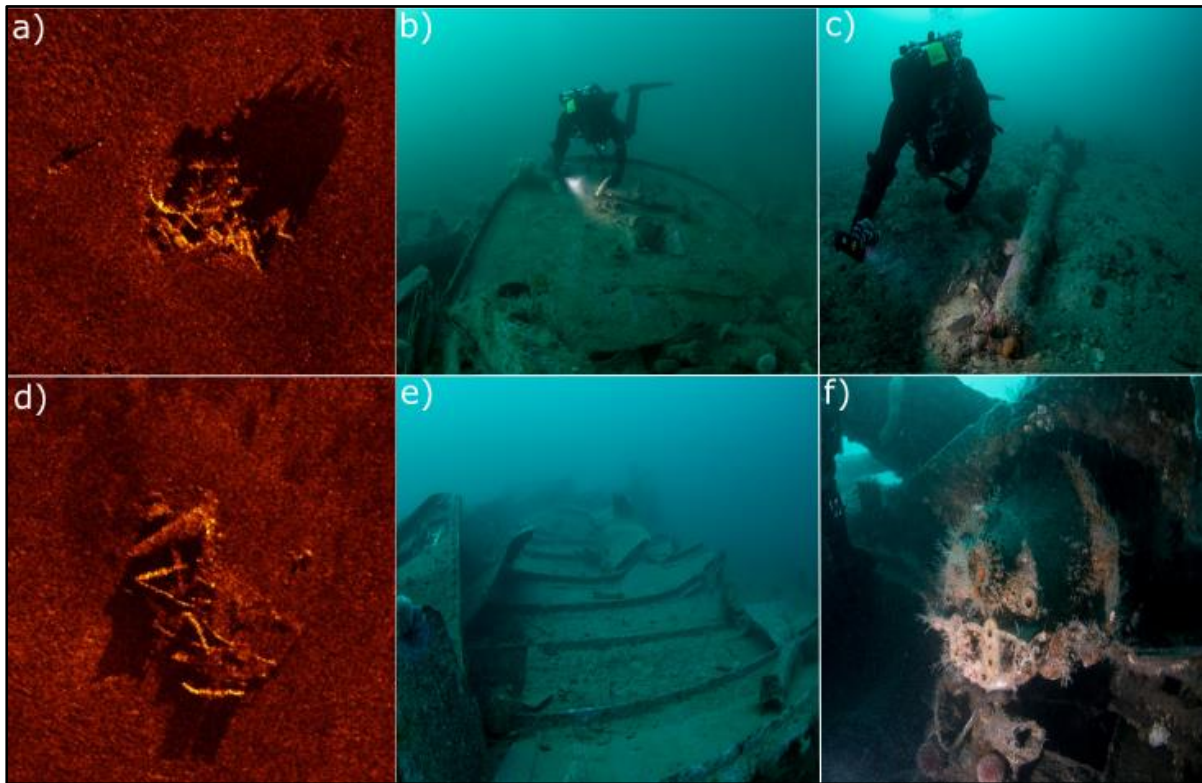
SS069 is the upper part of an upright searchlight platform with searchlights missing, electrical cables and plugs protrude through the searchlight apertures, and underneath the platform lies a coal winch and extensive debris ([Plate 14a; 14b](#)). SS071 is a searchlight control platform complete with two searchlight controllers ([Plate 14d; 14e](#)), one in-situ and the other has fallen out from its mounting ([Plate 14d; 14f](#)). The searchlight controller head is missing, and a junction box and morse key were located on this site. The platform shows no evidence for the mast penetrating the platform, indicating that it is a standalone platform typical of the Kaiser Class.

*Plate 14 a) side scan sonar image SS070 & SS069 b) SS069 searchlight platform c) SS070 8.8cm L/45 gun d) side scan sonar image SS071 e) SS071 searchlight platform f) SS071 in-situ searchlight controller*

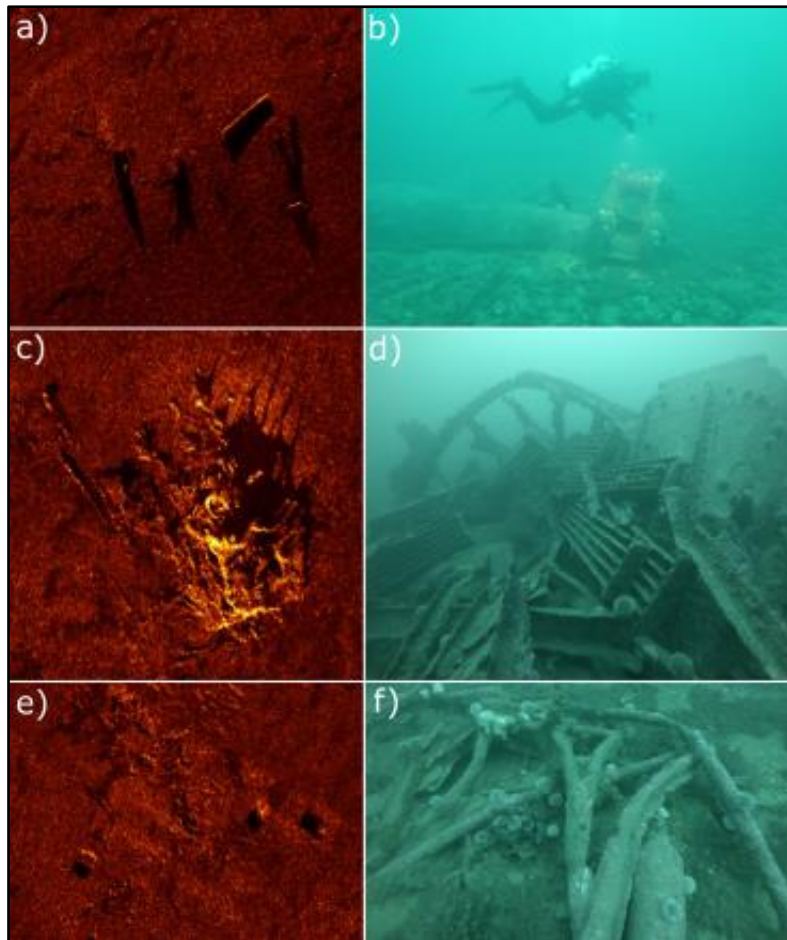
SS078 is an extensive area of heavily corroded funnel plating and bands, extensive grating and wires are visible ([Plate 15c; 15d](#)). A brass box with two switches and a small whistle is located on the site. Part of a platform is located here, possibly from a searchlight platform. A sub calibre gun barrel liner is visible on this site located inside its partially corroded cylindrical storage container. SS079 is an area of debris with funnel grating and in this area is a brass doorframe ([Plate 15e; 15f](#)). SS078 and SS079 are lying 32.8m apart centre to centre of contact, orientated 185-105 degrees. At SS068 there are two samson posts. One is buried in the seabed at one end and it rises at an angle of 45 degrees from the seabed at the other end ([Plate 15a; 15b](#)). Under this is a platform and beside this is a door with a porthole aperture and two hinges visible. The second samson post runs perpendicular to the previously described samson post and lies flat on the seabed, with copper pipes lying off to one side, which are possibly voice pipes. A mast with a small spotting top is located here, most likely an aft mast. A section of mast protruding at an angle from the seabed is also located on this site.

*Plate 15 a) side scan sonar image SS068 b) SS068 diver over samson post, partially buried in the seabed at this end c) side scan sonar image SS078 d) SS078 funnel plating and bands e) side scan sonar image SS079 f) SS079 large quantities of wire visible on this site*

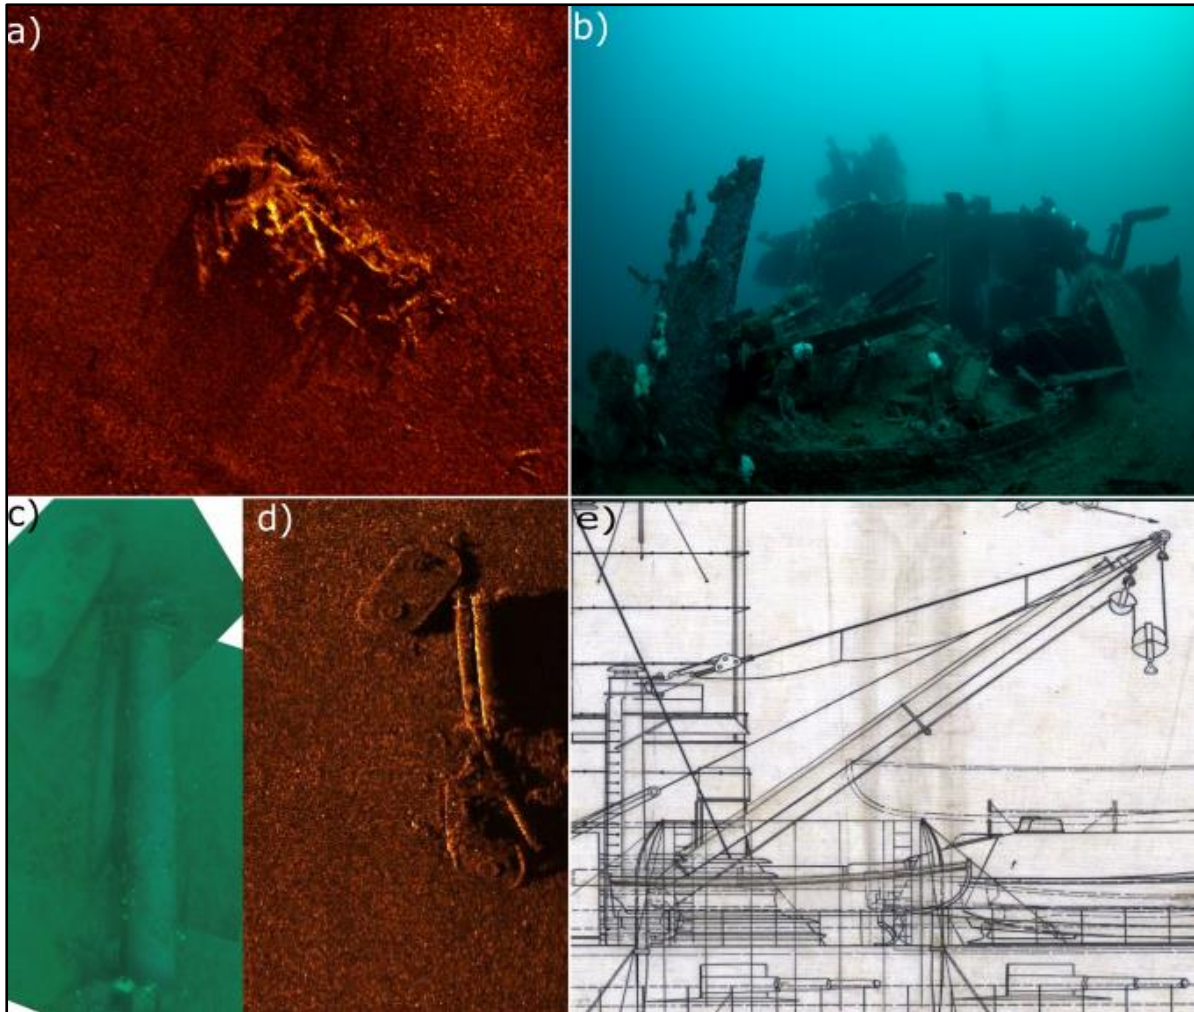
SS085 is bridge structure cabin with a heavily corroded surrounding platform. A sheared mast abuts the front of the cabin, the deck was formed to receive a curved structure, most likely the aft part of the armoured control room; funnel gratings are also present on this site ([Plate 16a; 16b](#)). The cabin is most likely of the Kaiser Class style. SS065 is a top searchlight platform, with a derrick arm and samson post along with a lower searchlight platform. No searchlights are visible ([Plate 16c; 16d](#)). There is a coal winch located to the south of this. In close proximity to SS065 is SS066, a derrick arm and samson post, and the remains of a deck mounted winch. There is an abandoned scallop dredge on this site. SS065 and SS066, because of their positioning on the seafloor, match the layout of a Kaiser Class vessel, which are offset one on the starboard forward funnel and one on the port aft funnel. The Kaiser Class derrick arrangement differs from the Konig Class due to their layout on the ship and pulley arrangement at the top of the samson post ([Plate 16e](#)).

*Plate 16 a) side scan sonar image SS085 b) SS085 bridge structure cabin c) SS066 photographic mosaic of the site showing searchlight platform, samson post and derrick arm d) side scan sonar image SS066 e) Kaiser Class derrick*
