## Survey of pinnacle wreckage, Scapa Flow, Orkney.

### Draft Report

**Submitted to:** Historic Environment Scotland

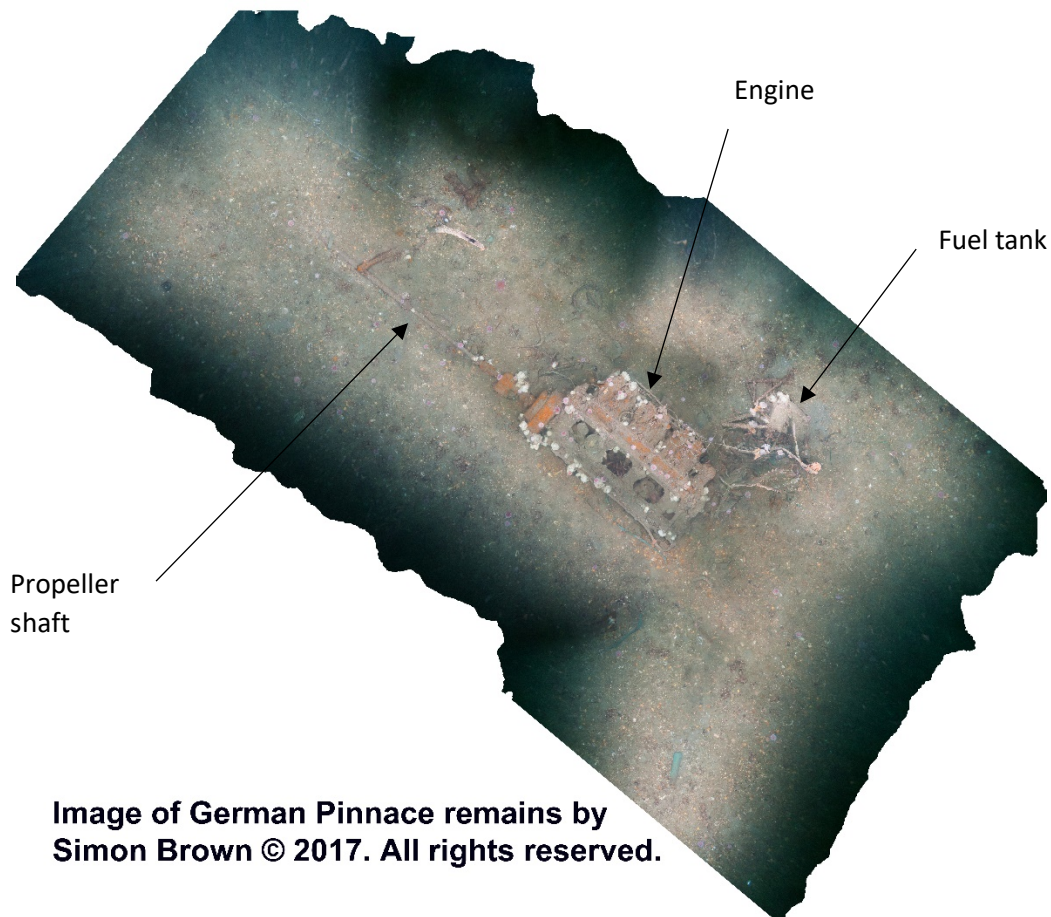
*Figure 1: Still image taken from 3D photogram of the wreck site constructed after the site was dived in April 2017 (image courtesy of Simon Brown).*

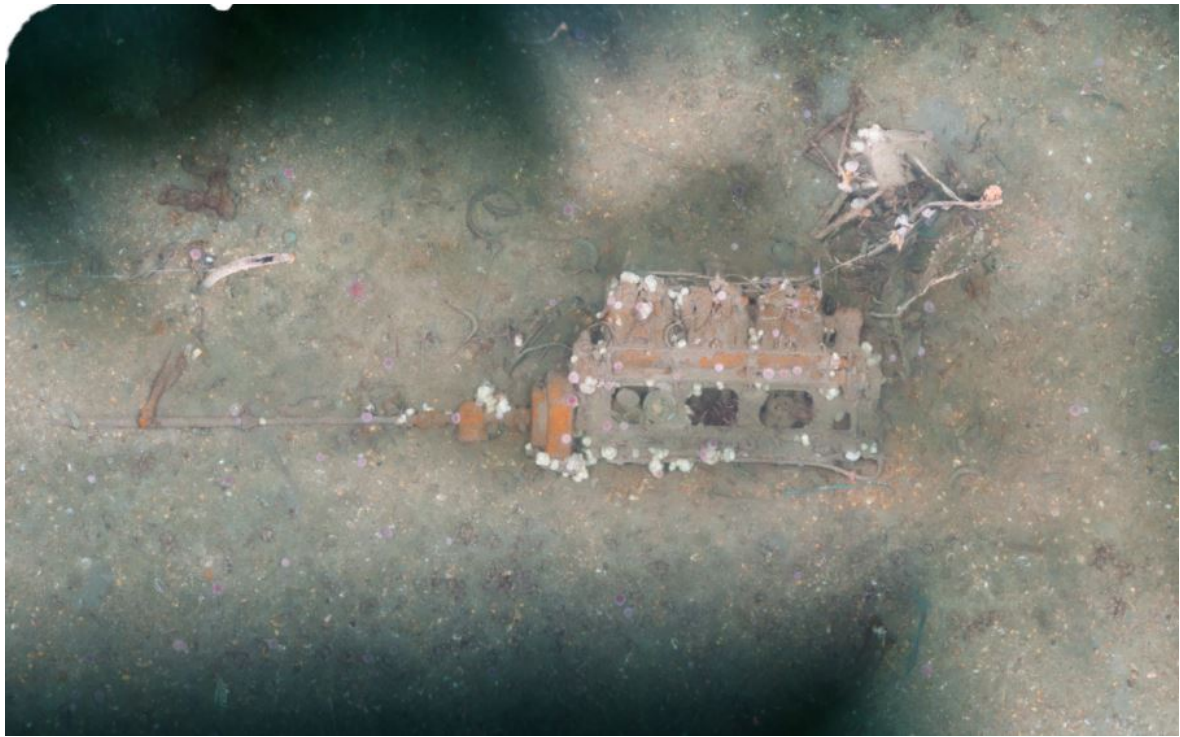
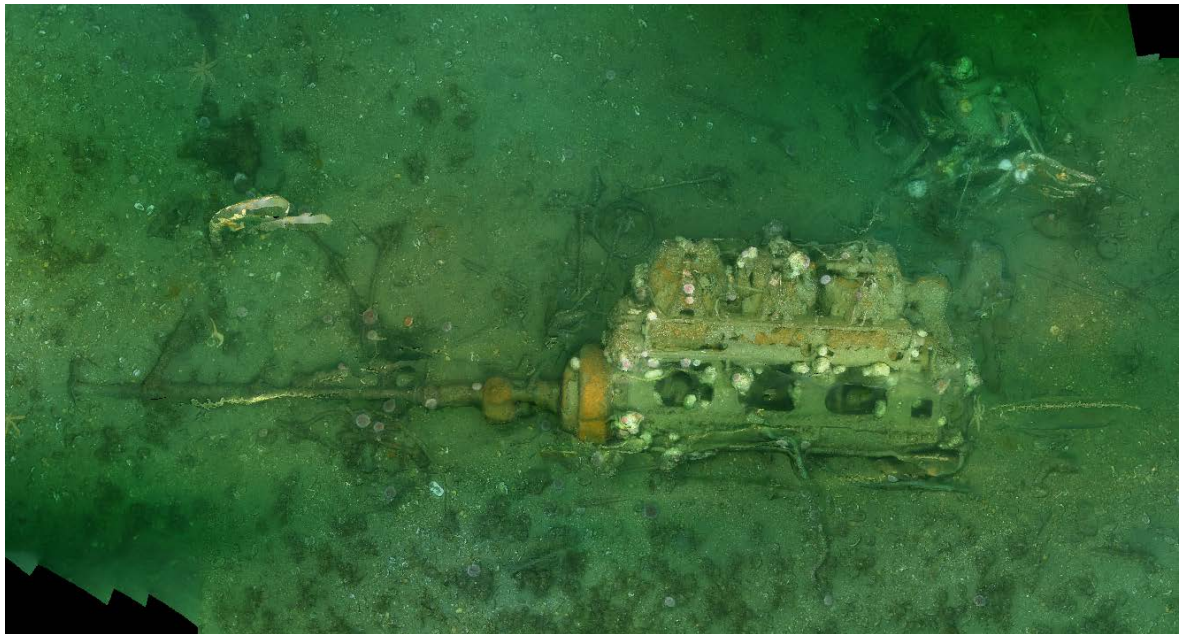
In comparison with the original survey results, a number of artefacts appeared to have been removed from the site. These included:

- 6 brass portholes
- A brass filler cap
- A shell casing.

*Figure 2: Original photo mosaic constructed from 2017 survey (top, courtesy of Simon Brown) compared to photomosaic constructed following the May 2018 survey (bottom). The fuel tank and associated pipework is located in the top right of each image.*

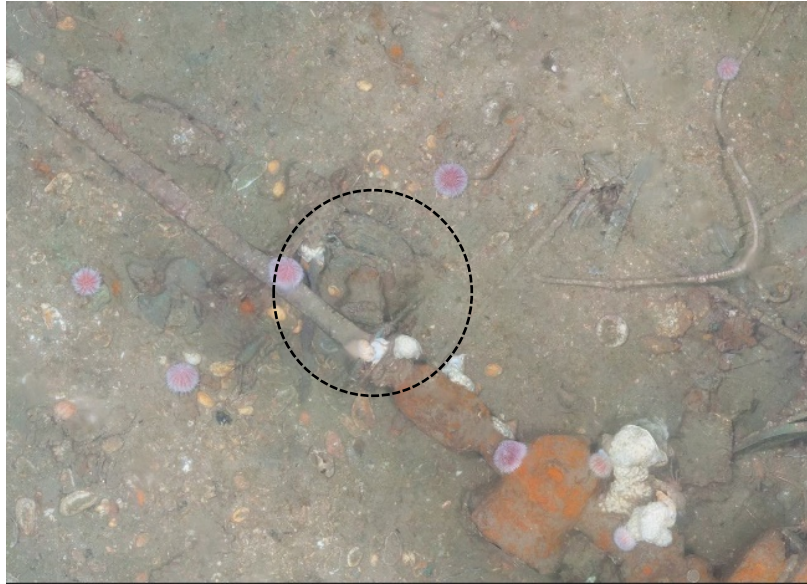
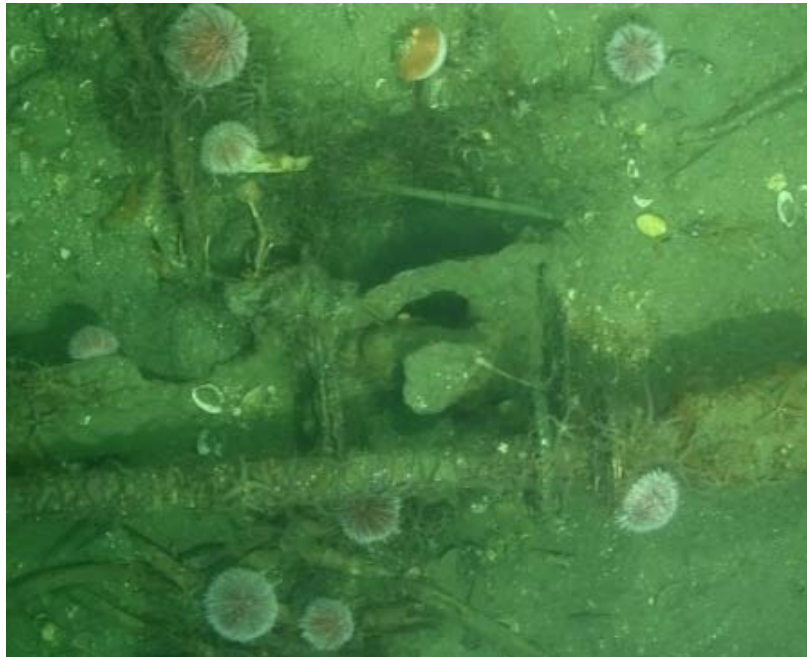
Porthole (1) by the propeller shaft (circled at top). The same section of shaft is shown in the lower image with a hole in the sediment where the porthole had been located.

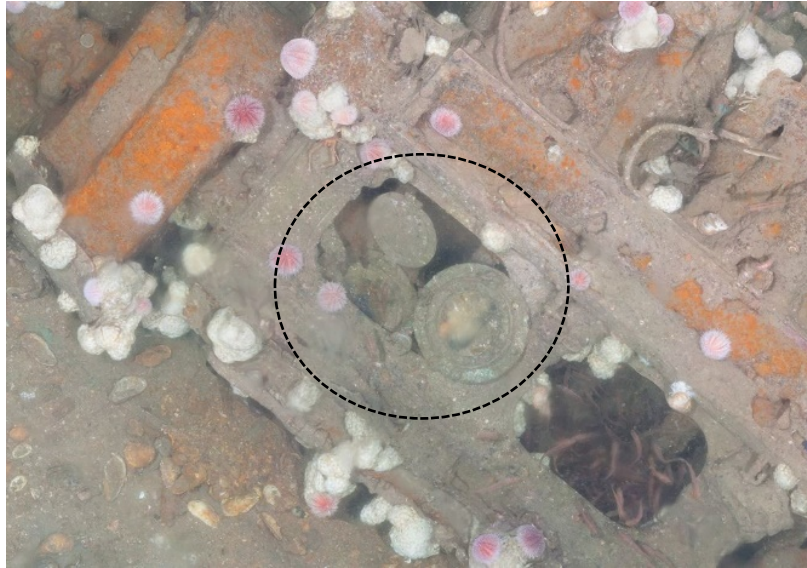
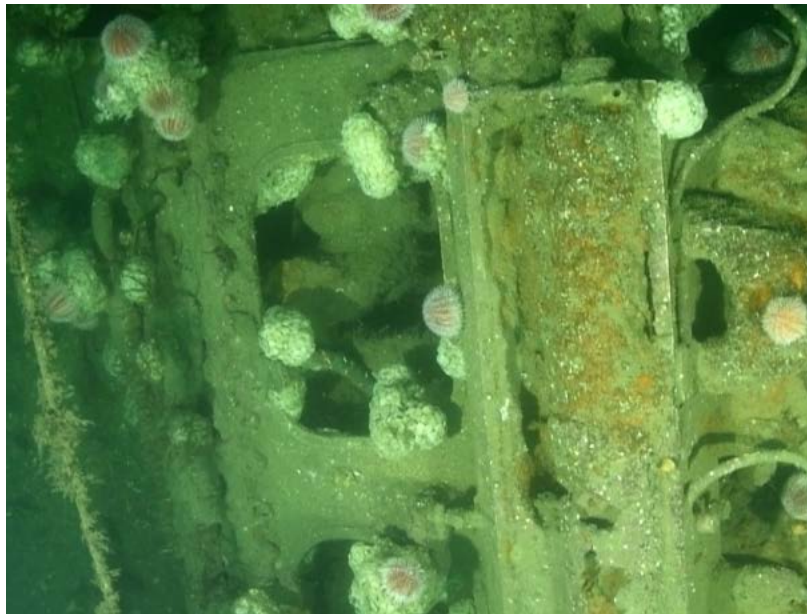
Portholes (2&3) lying on/in the engine casing (circled at top). The same section of engine is shown in the lower picture.

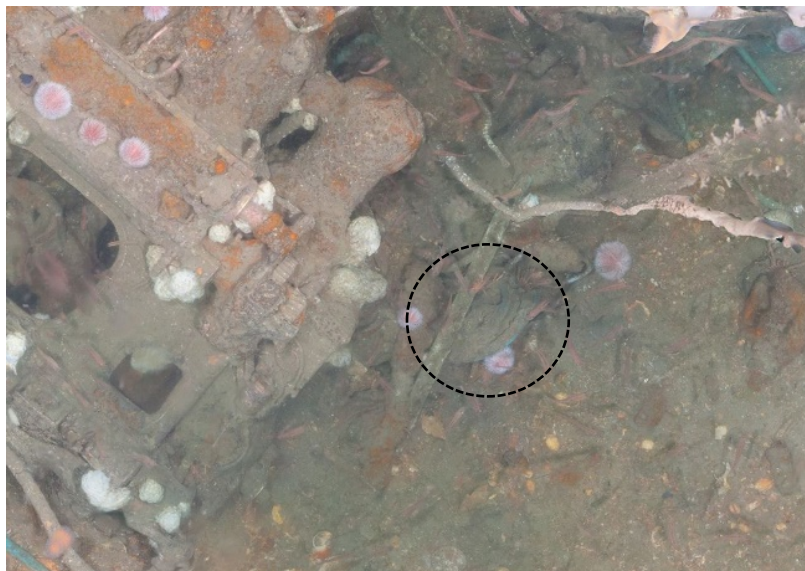
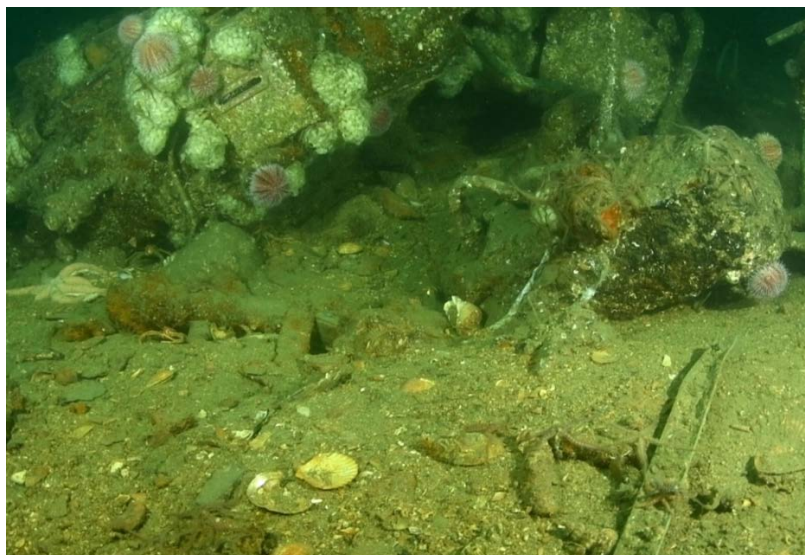
Porthole (4) lying on the seabed just forward of the engine (circled at top). The lower picture shows the same location and a disturbed area of sediment.

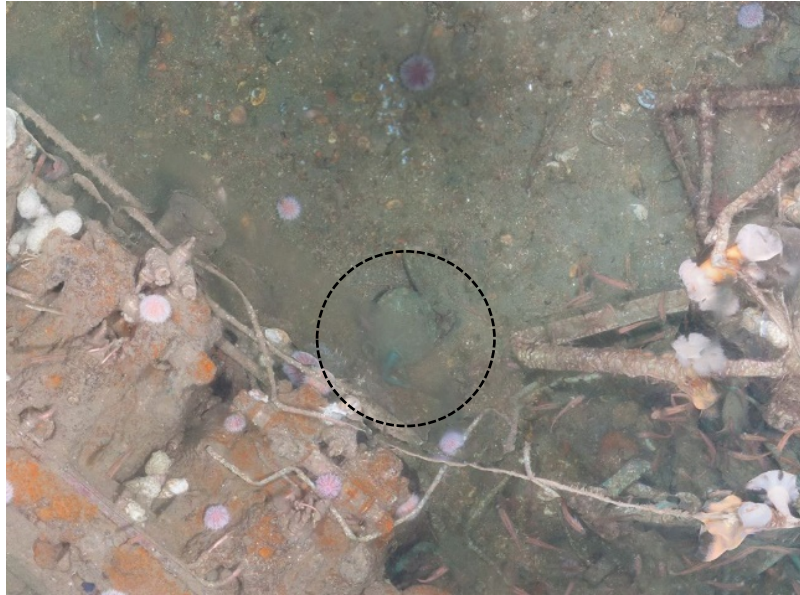
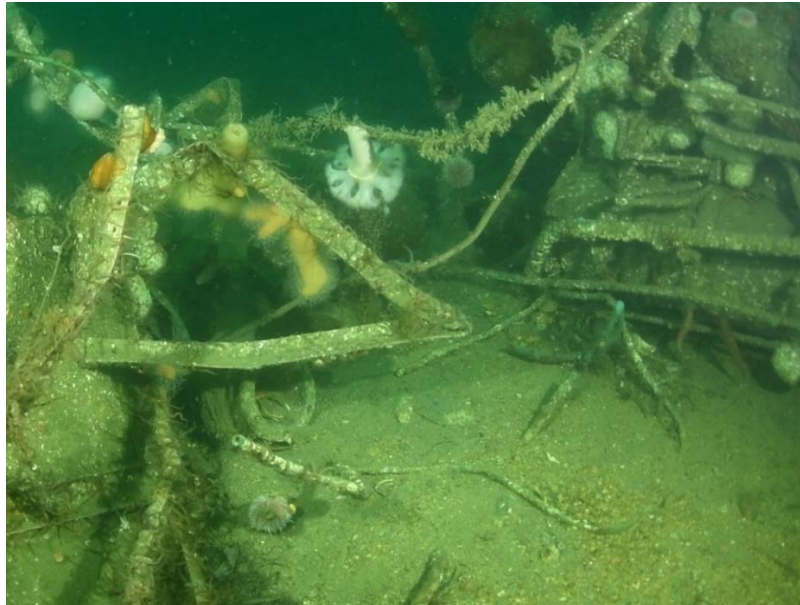
Porthole (5) lying on the seabed just beside the engine (circled at top).  
Lower picture shows same area in bottom right of image.

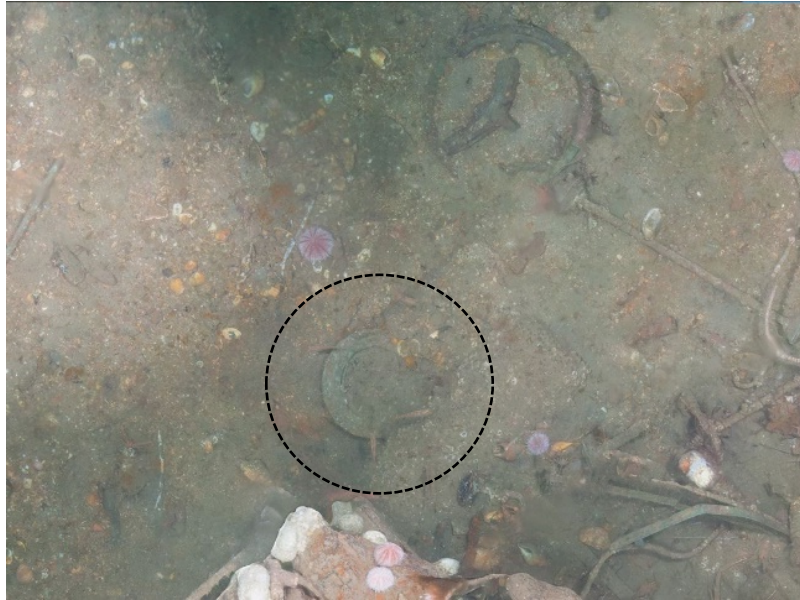
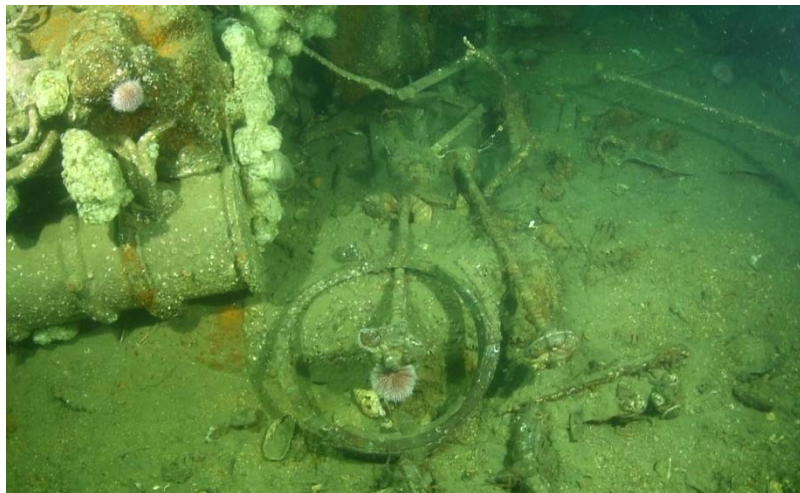
Porthole (6) lying off the aft end of the engine (circled at top) and brass ring from the ships wheel nearby. Lower image shows the same area, with the porthole absent. The brass ring and some pipework are now lying where the porthole was located.

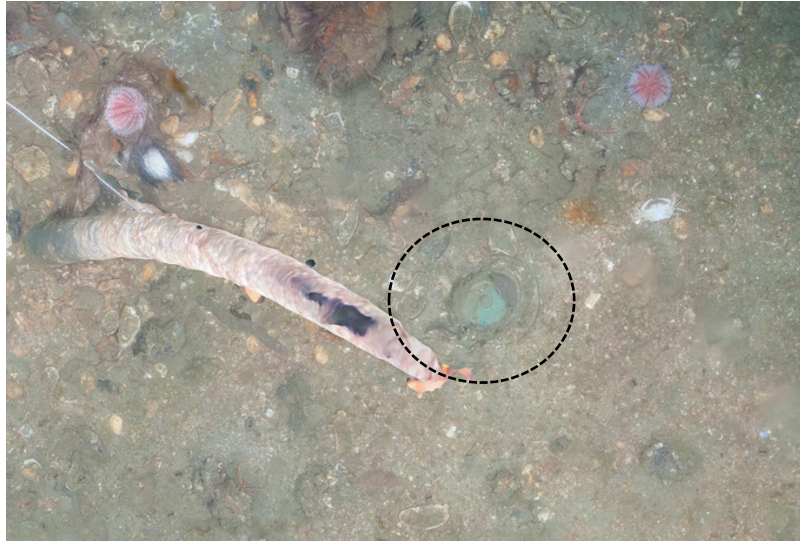
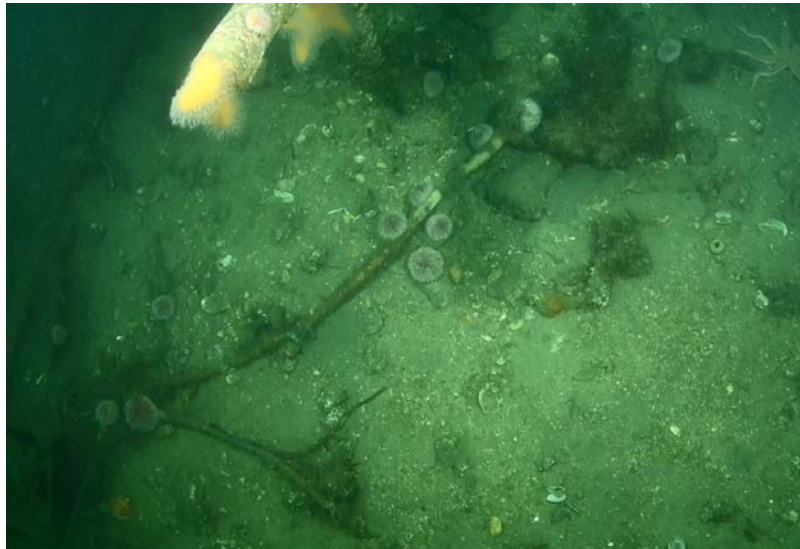
A brass fitting, possibly a filler cap (circled, at top) lying on the seabed next to curved section of metal sticking out of the seabed. The lower image shows the same area of seabed minus the artefact.

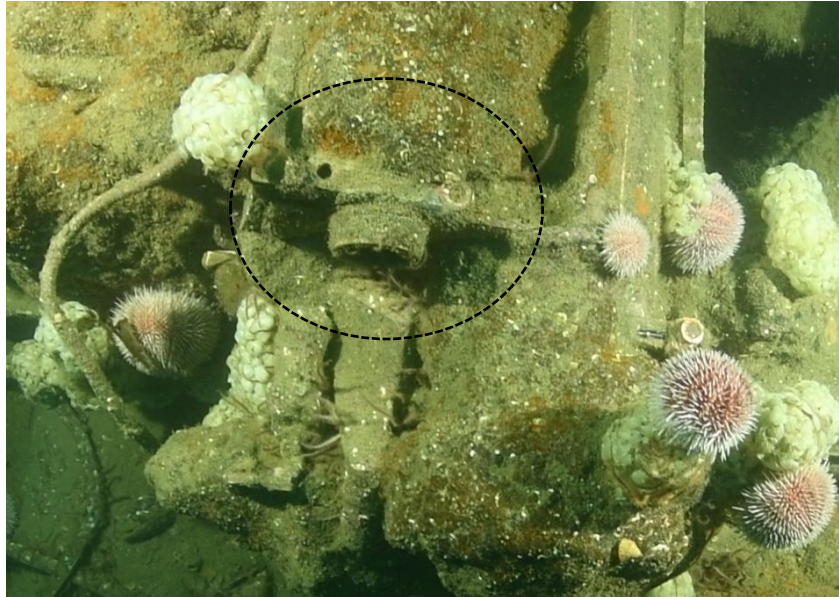
A hole and evidence of brass polishing (circled) indicates that something may have been removed from this area to the aft end of the engine.
