## **Wreck of the Edindoune (BF1118), Scapa Flow, Orkney.**

### **Final Report**

**Submitted to:** Historic Environment Scotland

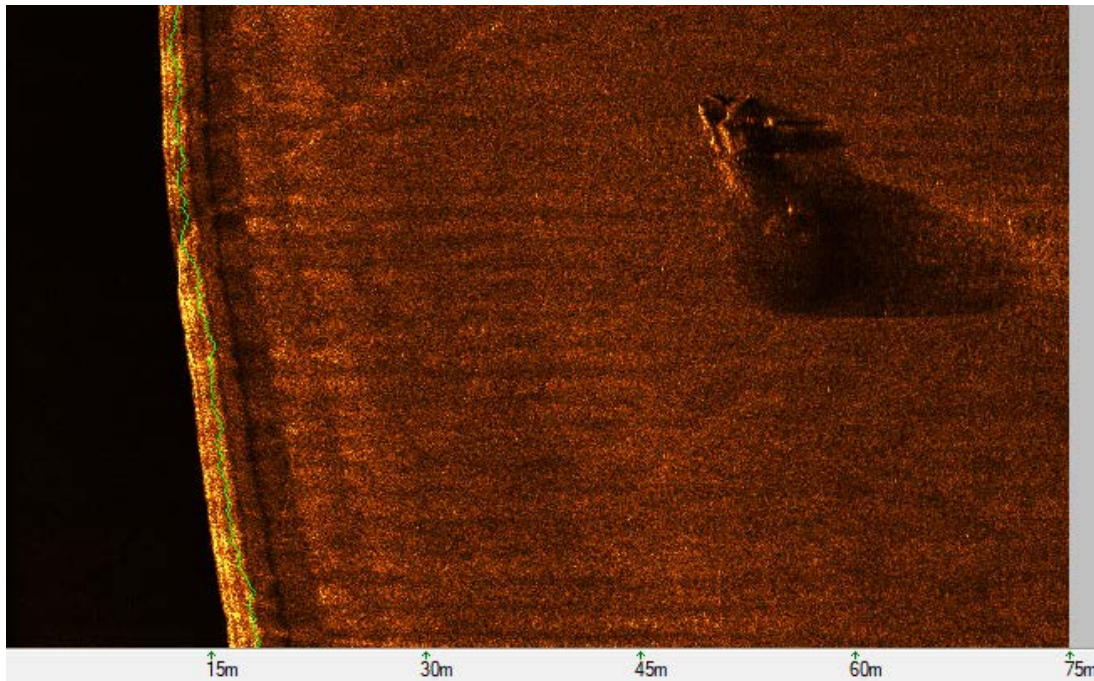
The high frequency side scan sonar survey of the site conformed the position of the wreckage as 58° 54.497' N, 002° 59.391' W. However, the survey did not yield more detailed images than those collected on the 24<sup>th</sup> June 2016, which used medium frequency. Despite passing the site from several angles, each image was incomplete or blurred (Figure 2). There was no obvious reason for this as the equipment appeared to be fully functional. One possible explanation was that the site was being obscured by a large shoal of fish. This would explain why some images clearly showed parts of the wreckage, but other parts were “blurred out”. Sonar images showed a large sonar shadow but no hard return, which might result from biological material that was densely clumped. Shoals of fish are attracted to seabed features such as wrecks.

Figure 2: Side scan sonar image of the wreck site collected on 1<sup>st</sup> February 2018, showing obscured part of the site. The sonar shadow to the right of the site suggests the presence of a confounding feature over the site although there is no hard return.

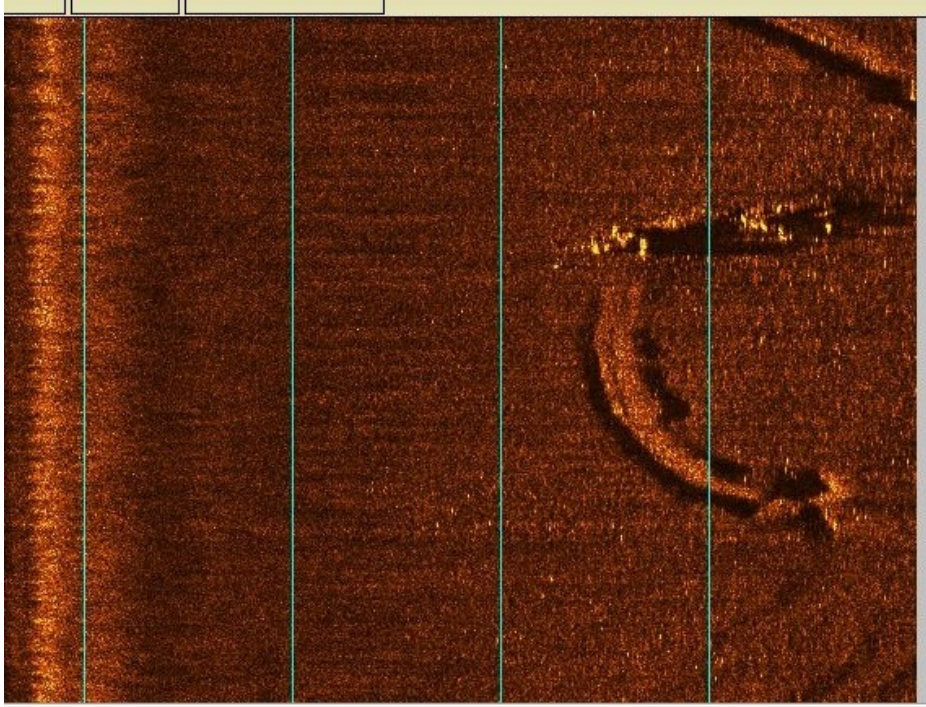
The original sonar image of the site collected in January 2016 (Figure 4) shows what appears to be a drag mark on the seabed leading to (or from) the wreck site that has disturbed a large amount of sediment.

*Figure 4: Original sonar image of the site collected using medium frequency (325 kHz) in January 2016, showing a drag mark on the seabed close by the wreck.*

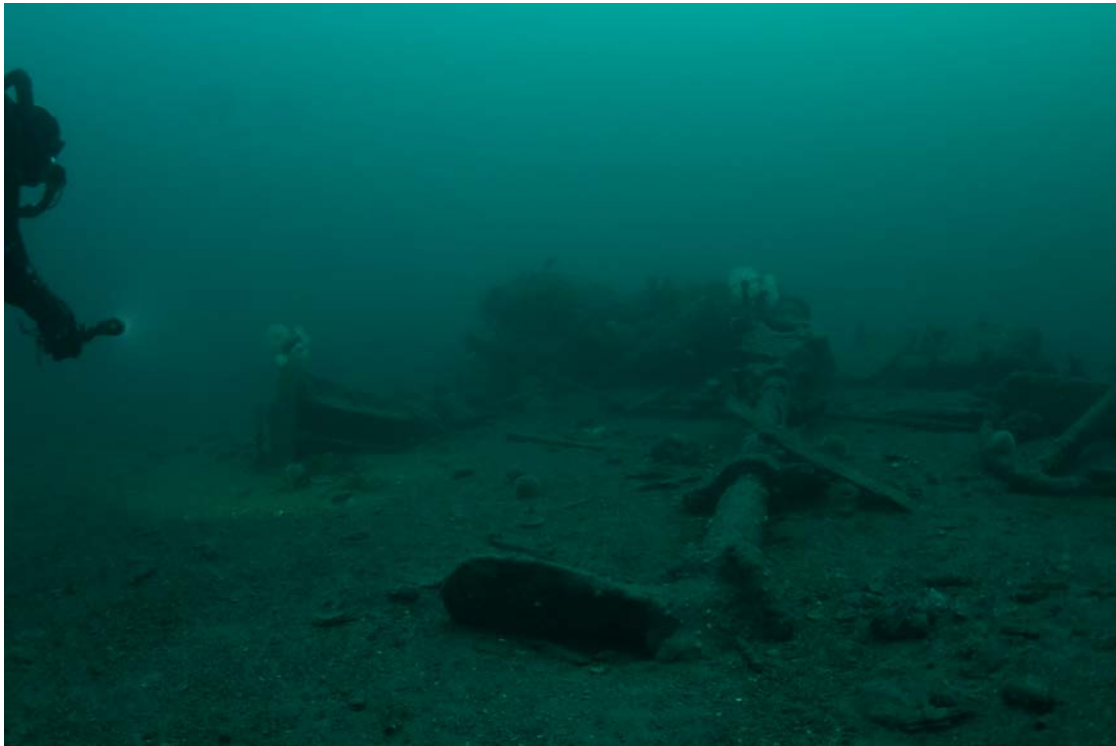
- Propeller and shaft (Figures 5-7). The propeller was partially buried with one blade lying parallel to the seabed and the remaining stump of another angled slightly upwards, the angle between suggesting a third blade was present but completely buried. The shaft passed through a metal box, possibly a thrust block, before running forward to the engine. The shaft lay at an angle to the engine, suggesting it had moved from its original line. The flanges where the shaft was connected to the engine had separated.
- A mast tabernacle was located just to one side of the propeller shaft (Figure 5).
- Engine (Figures 8-13). The two-cylinder engine was mounted on a heavy steel frame and was lying on its port side, exposing the concrete ballast below. A gearbox with gear lever were located on the aft end of the engine from which the propeller shaft was become detached. A

*Figure 5: Stern area of wreck, showing propeller in foreground, shaft and engine to the rear. A fisherman's type anchor is shown to the right and a mast step to the left.*

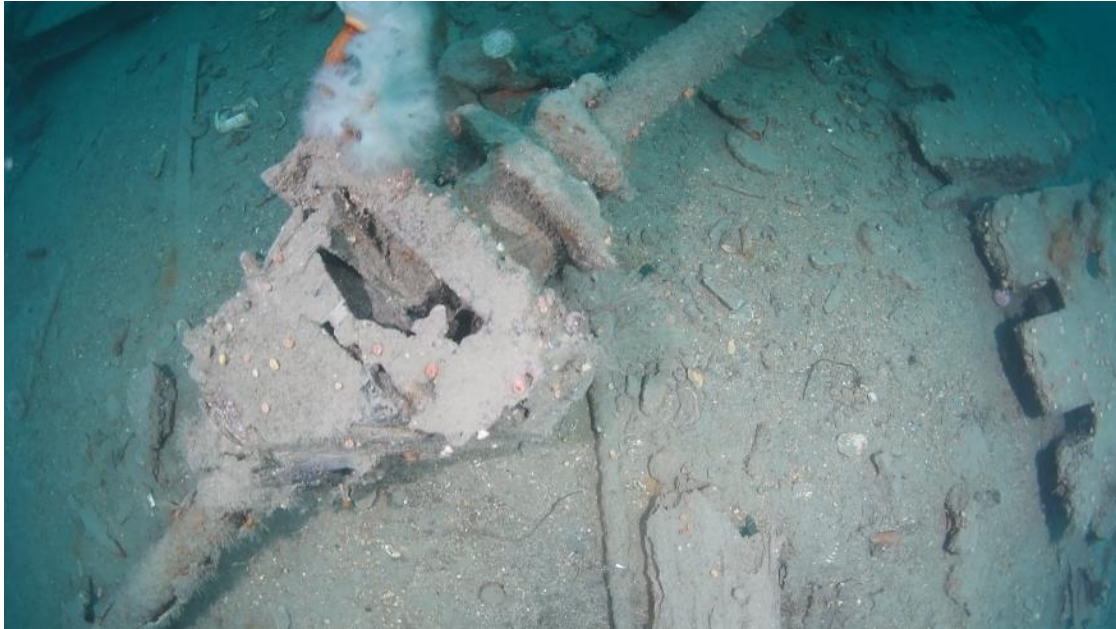
*Figure 6: The propeller shaft passes through a metal box, probably a thrust block, as it runs forwards to the engine.*

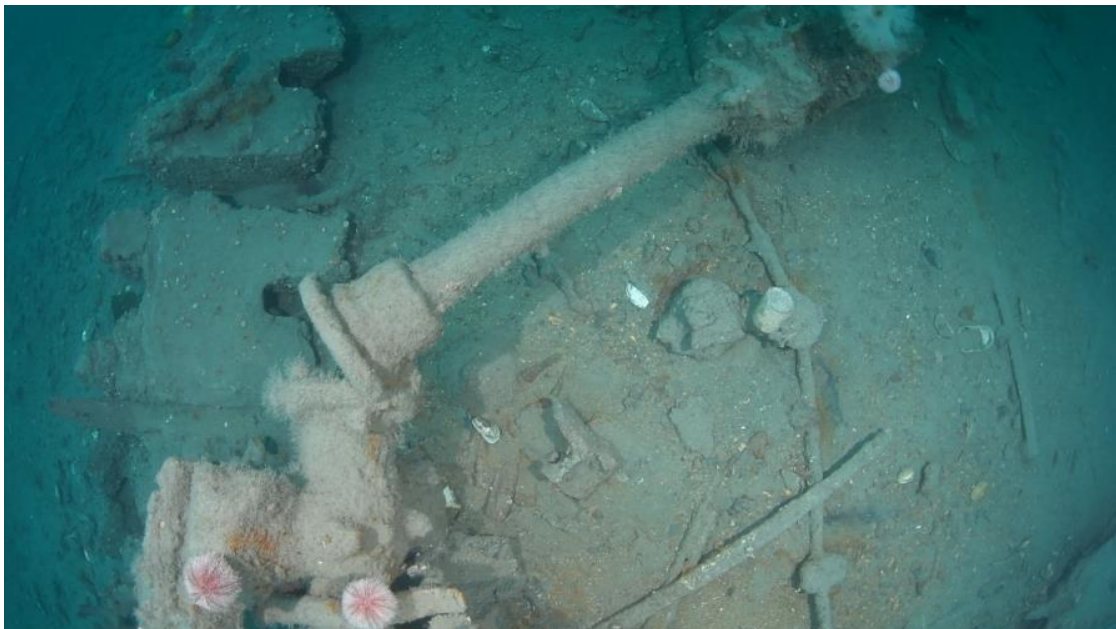
*Figure 7: The propeller shaft and gearbox flanges (lower left) were separated, with the shaft lying at an angle to the line of the engine and gearbox. Concrete ballast is visible to the left side of the image.*

- The layout of the main features described above suggested that there had been minimal site disturbance. However, the propeller shaft appeared to have been dragged a short distance away from where it might have originally settled.

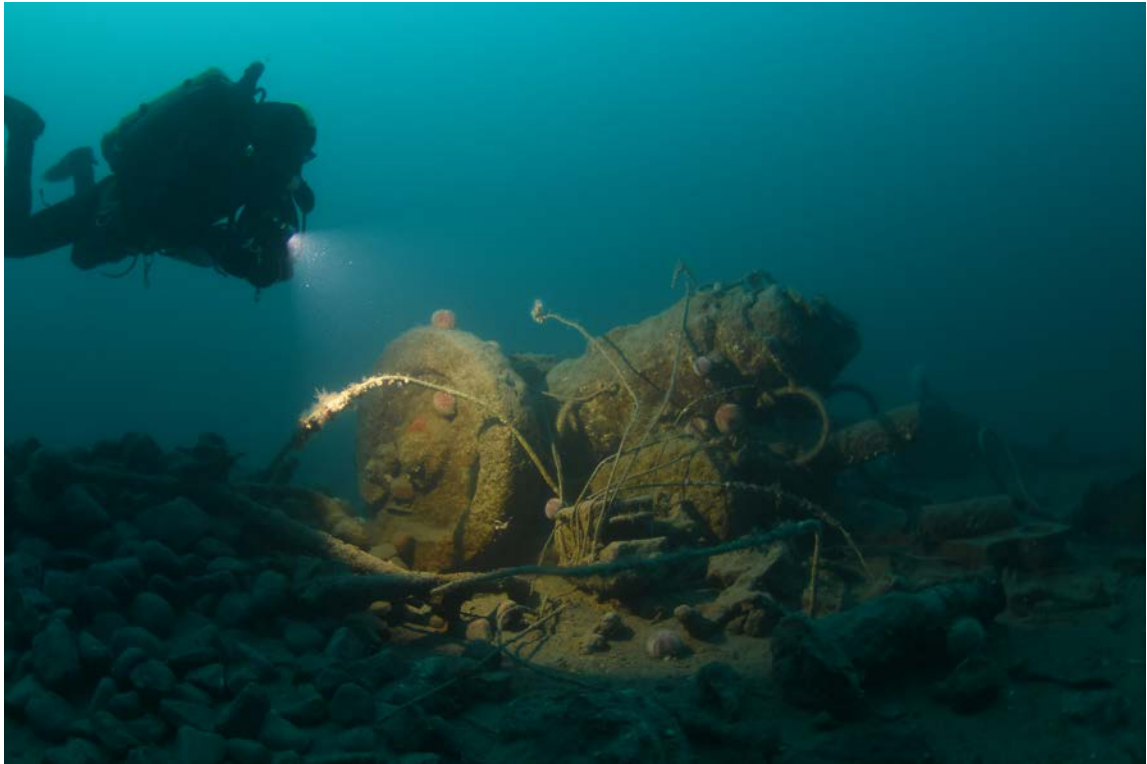
*Figure 8: Two-cylinder engine with large fly-wheel on forward end. Start of ballast pile to left of image.*

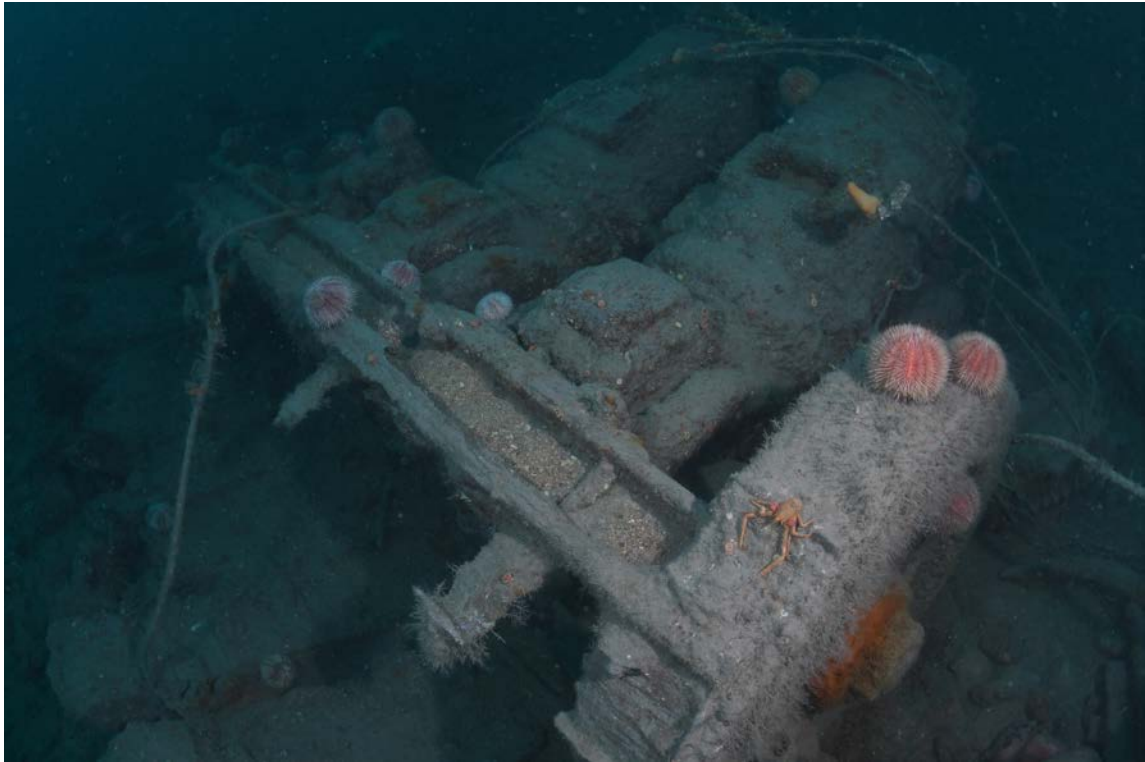
*Figure 10: Close up of engine showing two cylinders, flywheel and mounting frame. The engine had fallen to port, exposing the concrete ballast below (left of image).*

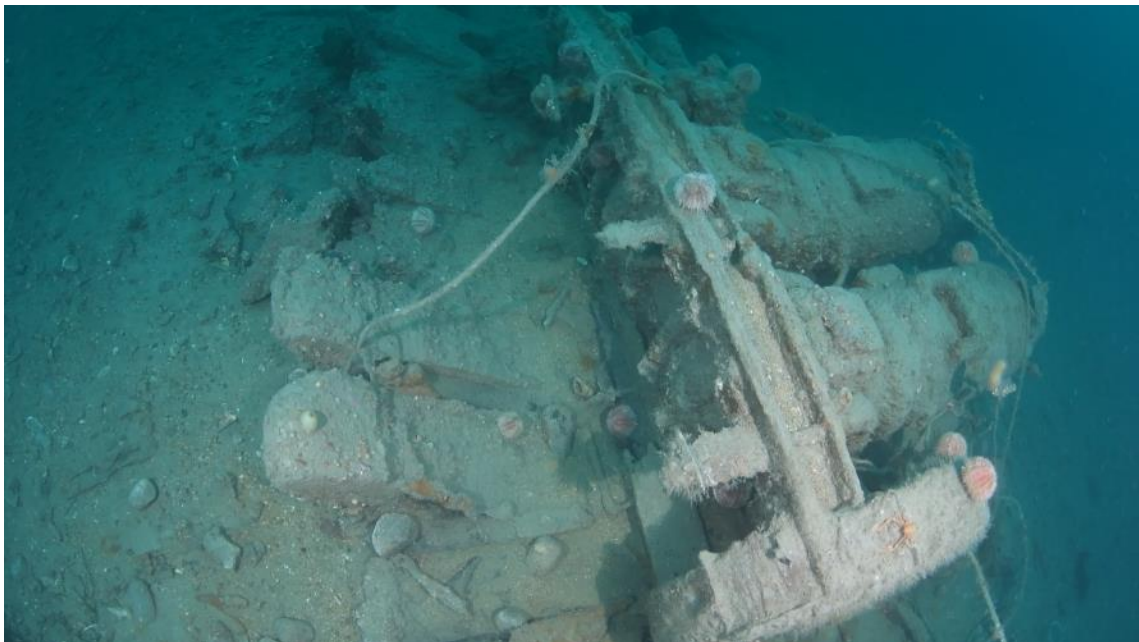
*Figure 11: Concrete ballast below engine showing rib voids.*

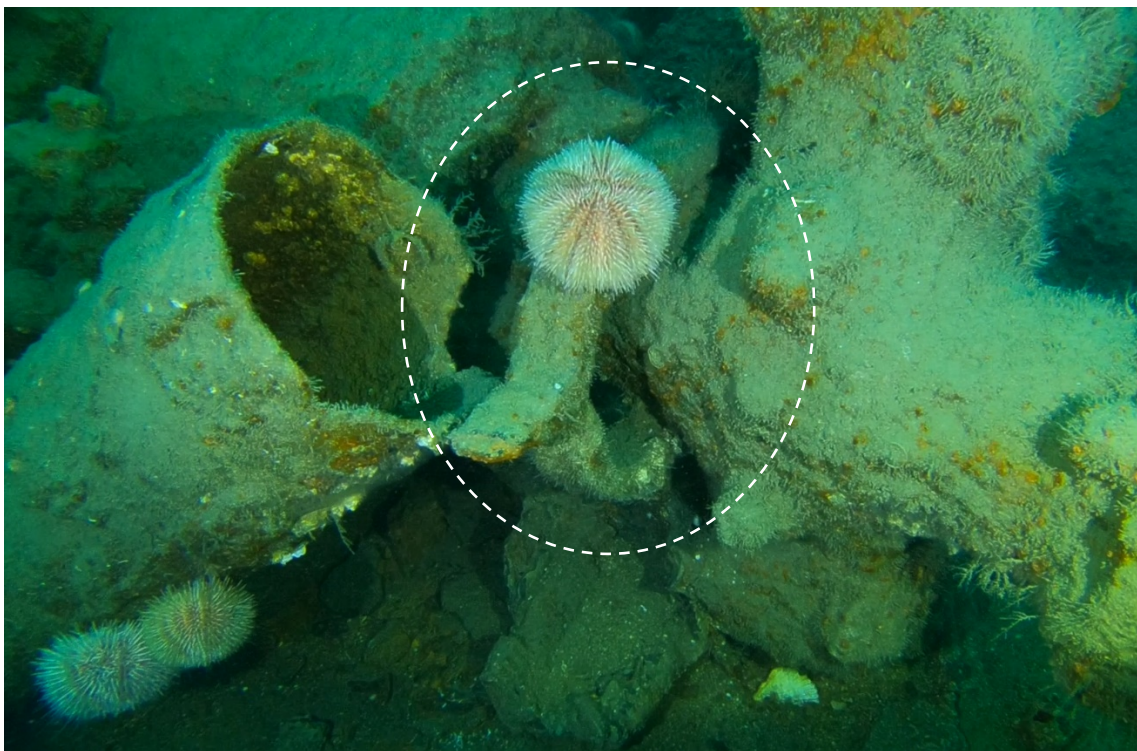
*Figure 13: Engine gearbox showing remains of gear change lever (circled).*

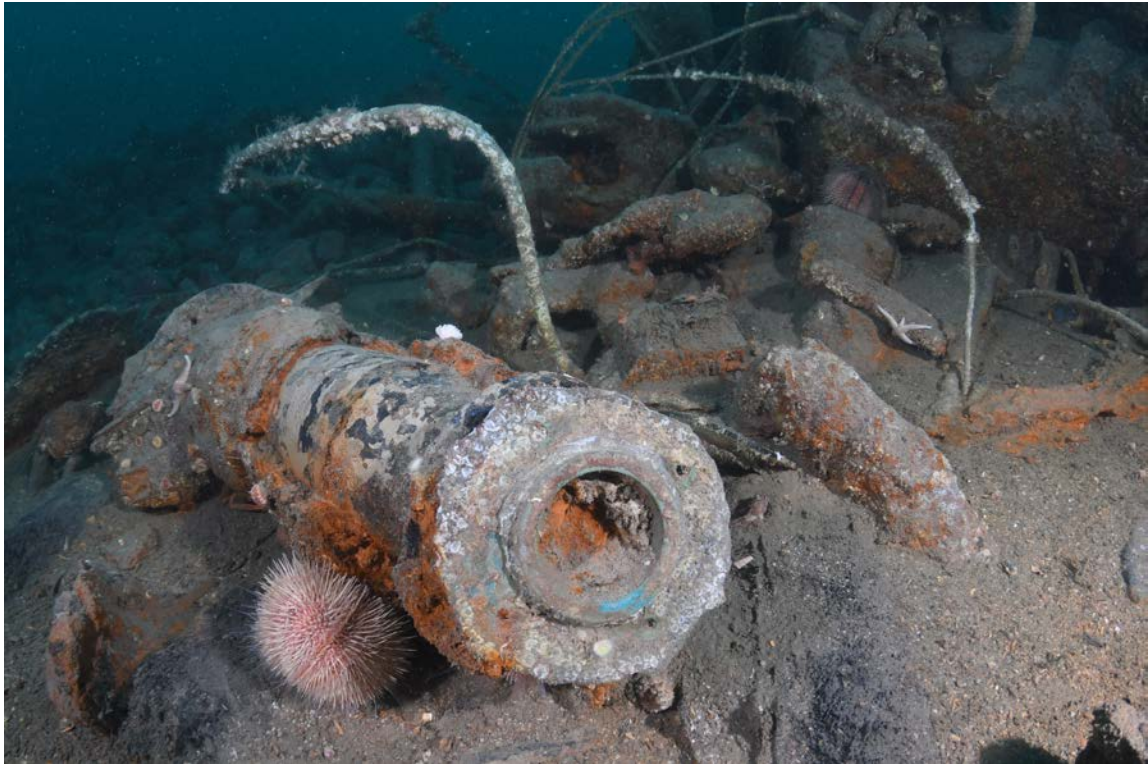
- A metal cylinder lying to the north side of the engine may be a ship's helm. No wheel was present however. Broken glass was found lying beside this item, possibly the remains of wheelhouse windows (Figure 14).

*Figure 14: Metal cylinder lying next to the engine, possible the ship's helm. Broken glass was lying on one side of this item, possible from the wheelhouse windows.*

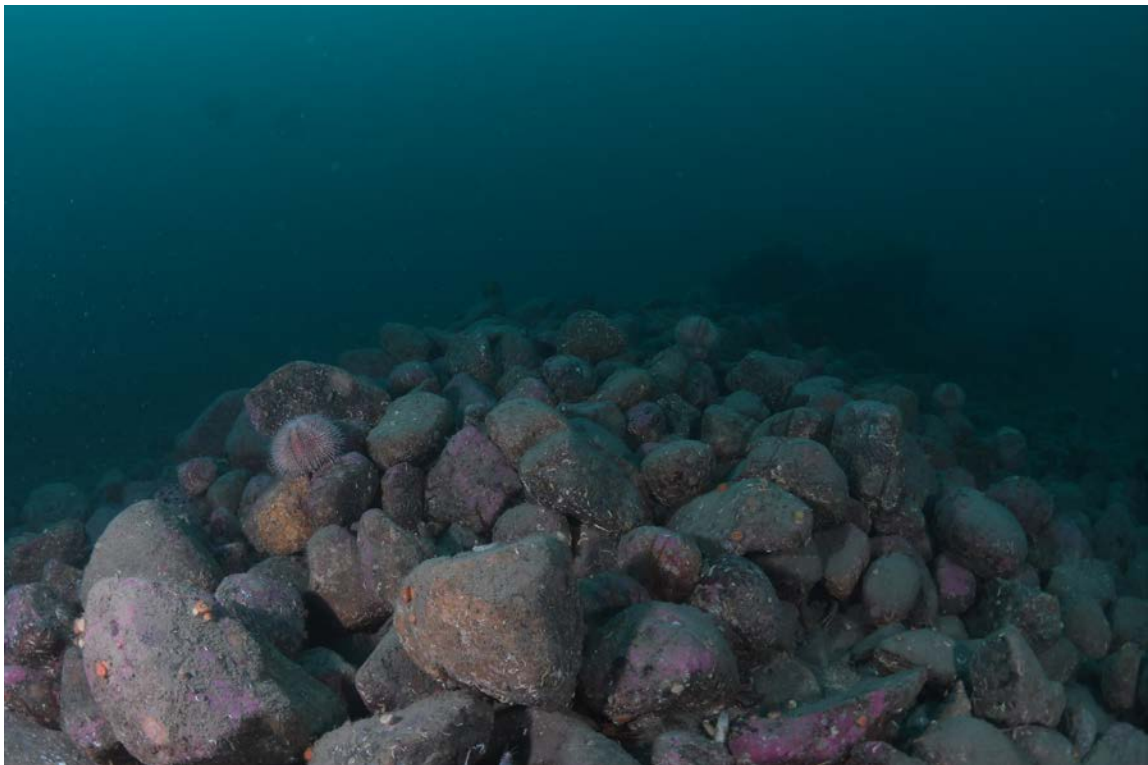
- Ballast pile (Figure 15). Located immediately forward of the engine was a ballast pile that measured approximately 5m long by 2m wide. It was composed entirely of beach type cobble stones of a relatively consistent size. The pile was entirely clear of wreckage, apart from a fisherman's type anchor located close to the engine on the north side.

*Figure 15: Ballast pile, comprising rounded beach cobbles. The engine is just visible in the background.*

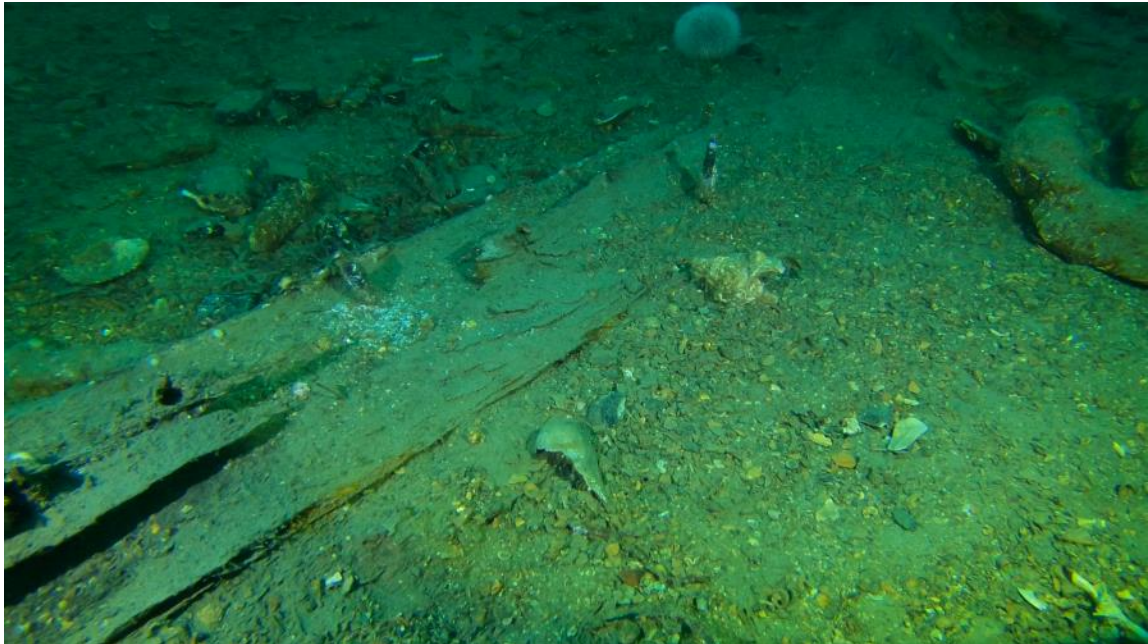
- Heavy timber (Figures 16 & 17). A heavy timber ran forward from the ballast pile and was mostly buried with only its top surface evident. Copper nail heads were protruding from the top surface of the timber. Its size and orientation (running aft under ballast pile and in line with the concrete ballast under the engine) suggested that this was the keel timber. A smaller section of timber lay off the front end that may have been the bow stem.

*Figure 16: Heavy timber buried in the seabed with copper nail heads.*

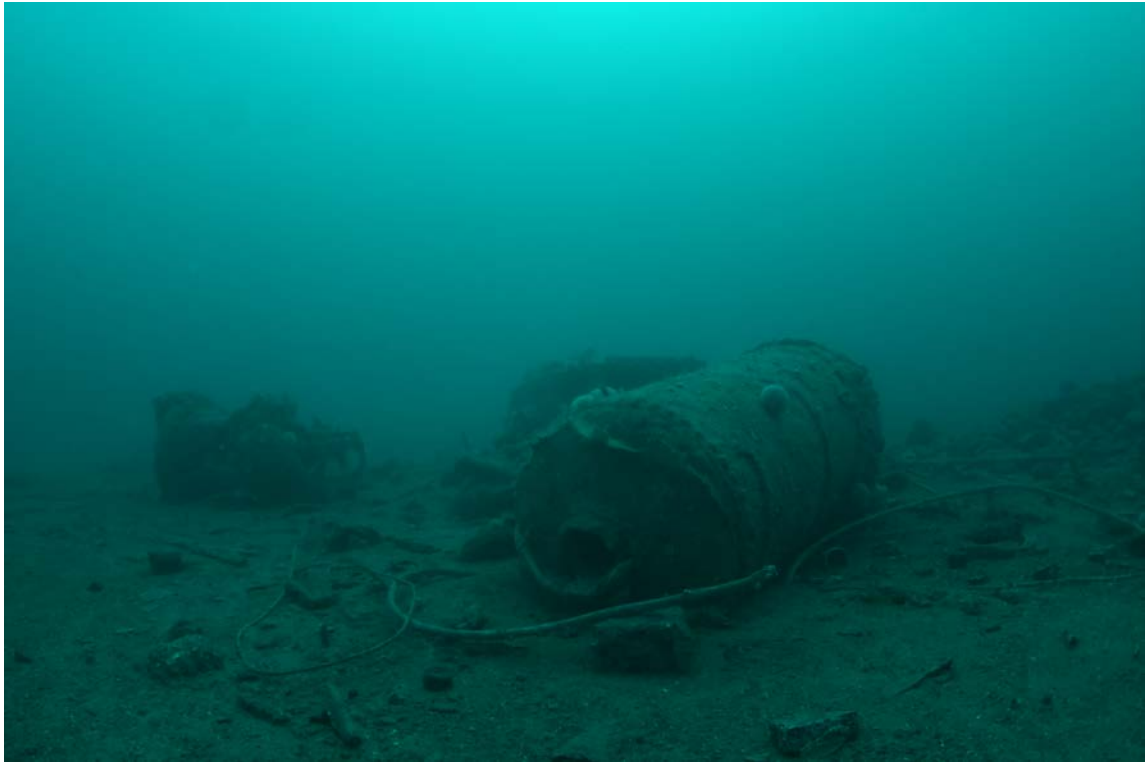
- Boiler & capstan winch (Figures 18-20). These were located forward of the ballast pile. The boiler, which was lying on its side, was 1.6m in length and 0.7m in diameter. A hole on one end was most likely for its funnel (not seen) which together with the location of the stoking hatch suggested that it was installed in a vertical orientation. The remains of timber sheathing were evident on the outside of the boiler. The capstan winch was of the classic herring drifter design and was most likely made of cast iron. A large amount of copper pipework was also found associated with the boiler and capstan.

*Figure 18: Group of objects lying forward of the ballast pile (visible to right of image), including a boiler (foremost), capstan winch (to left), mast step and anchor chain (rear of group).*

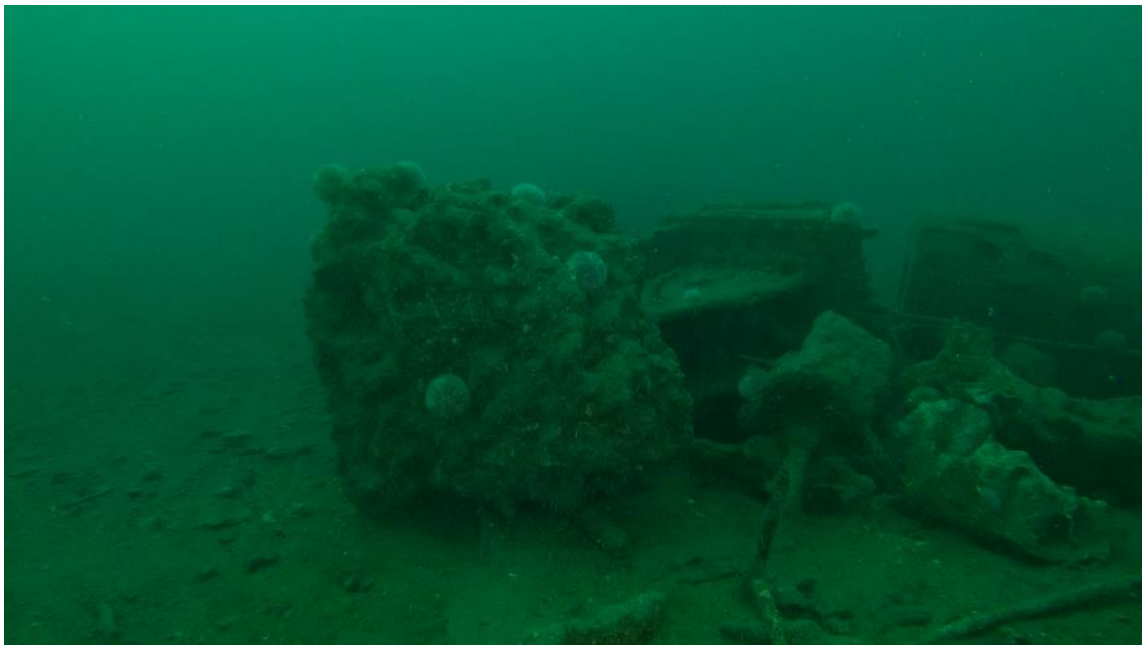
- Chain clump and mast tabernacle (Figure 21). A large lump of what appeared to be concreted chain was located next to the capstan winch. This may have been the anchor chain that would have originally been stored in an anchor locker, which has eroded away to leave just the chain. Another mast tabernacle was located beside the chain clump.

*Figure 21: Lump of concreted chain with mast step behind.*

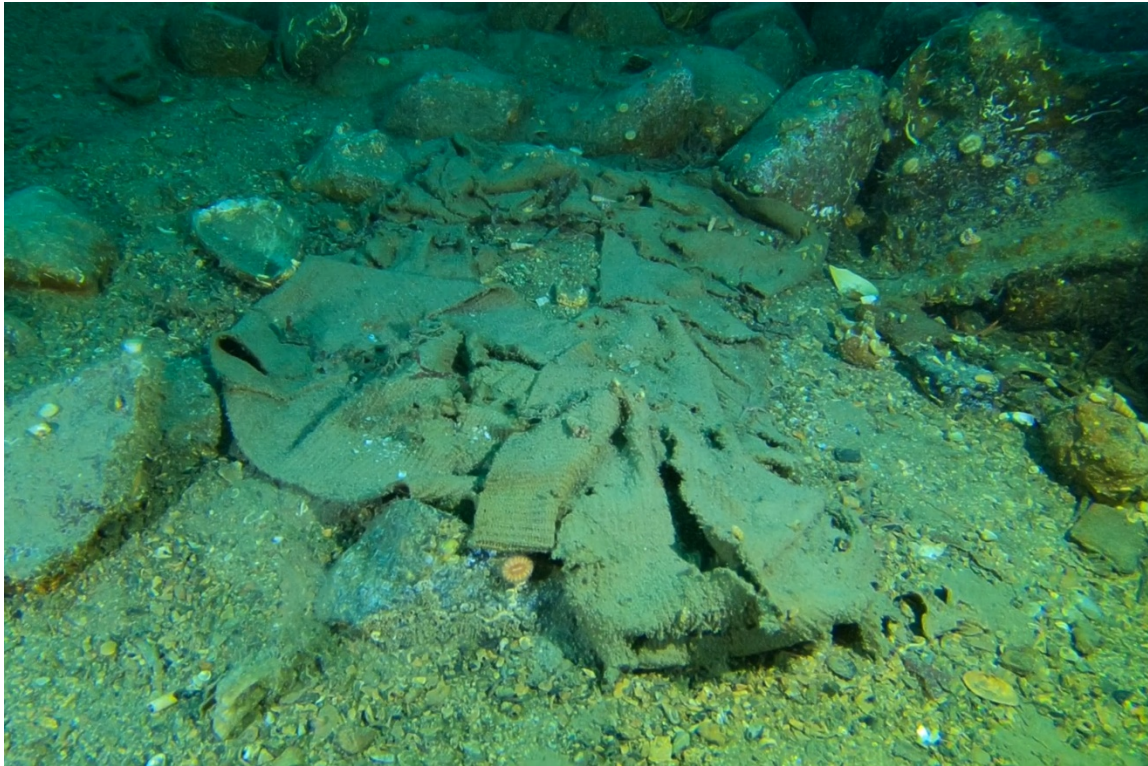
*Figure 24: Patch of material lying on the seabed, just forward of the ballast pile.*

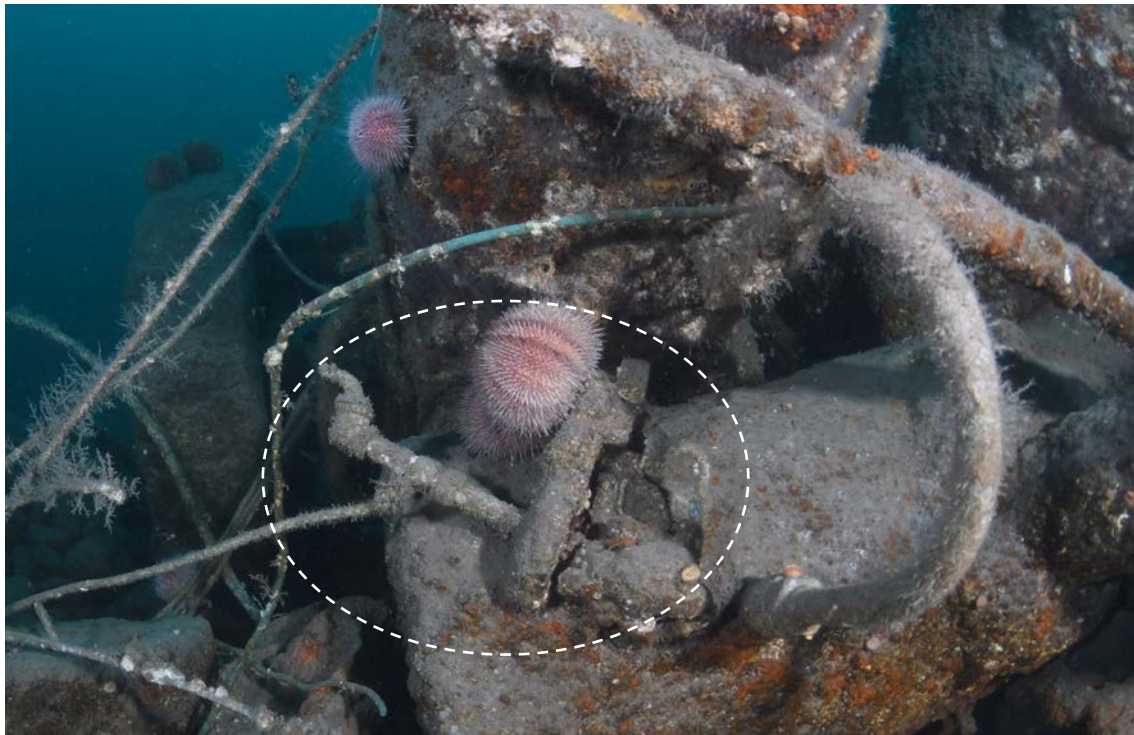
Figure 29: Small item (circled) lying on the engine that may be the blow lamp used to heat the glow plugs on this type of engine. The blow lamp was dropped into the bilges and started the fire that sank the Edindoune.
