**Scapa Flow Ship Time Project**  
**A Collaborative Multidisciplinary Remote Sensing Survey,**  
**Orkney**

| Title: | Scapa Flow Ship Time Project: A Collaborative Multidisciplinary Remote Sensing Survey, Orkney |

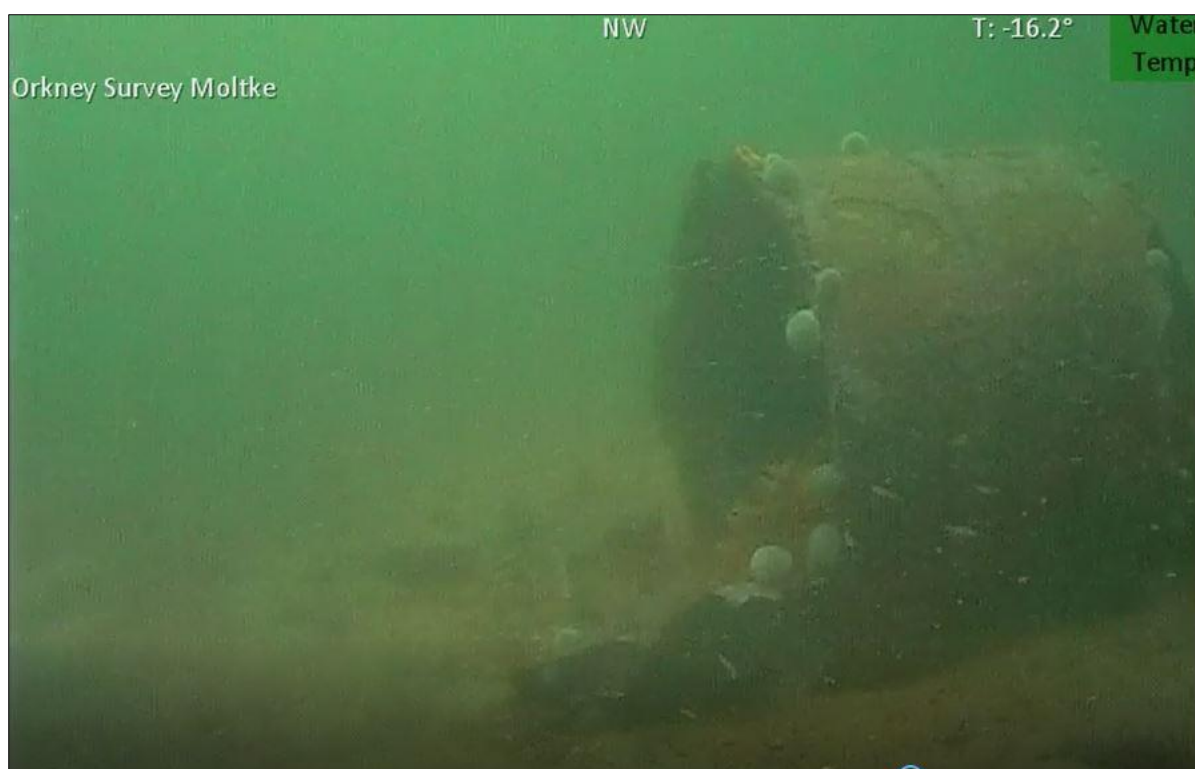
Figure 8: Moltke salvage site spotting top

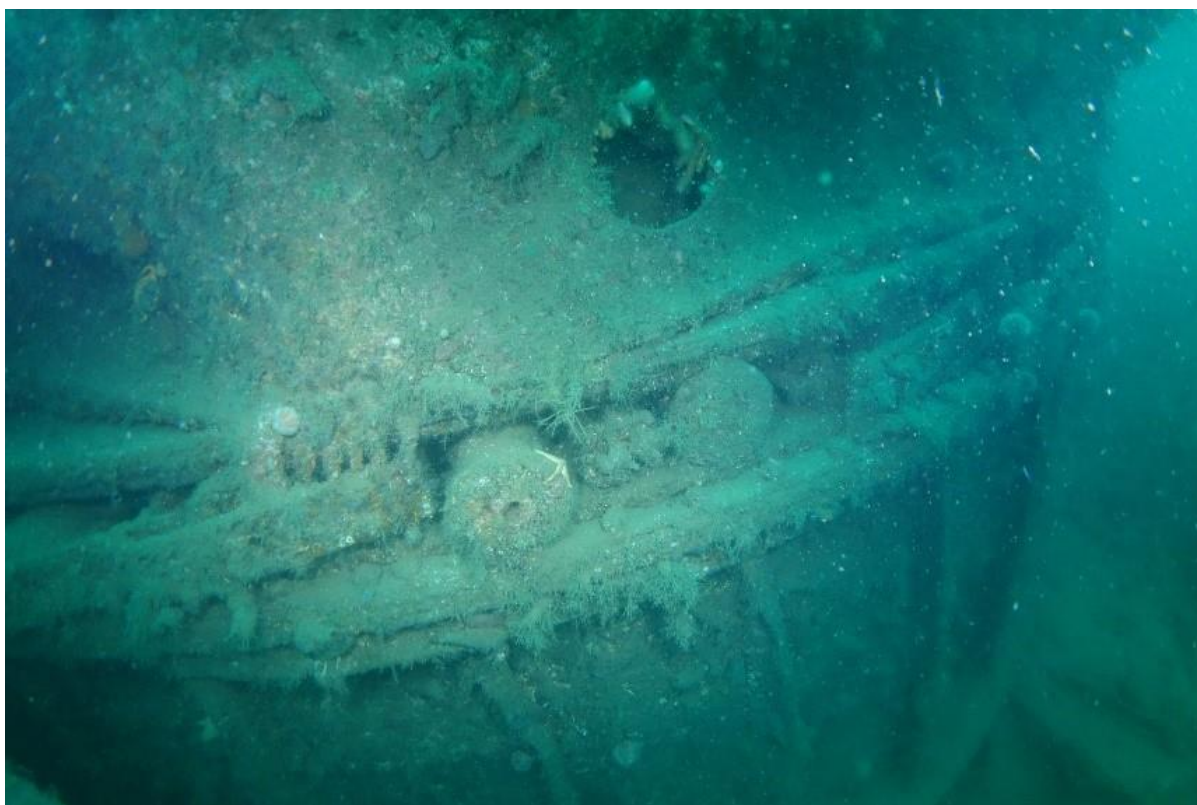
Diving focused on the stern of HMS *Vanguard* and the surrounding wreckage. Additional dives were carried out on the bow section located 203m from the stern with the aim of characterising the biological communities present on the wreck structures.

*Figure 9: Turret wreckage on HMS Vanguard*

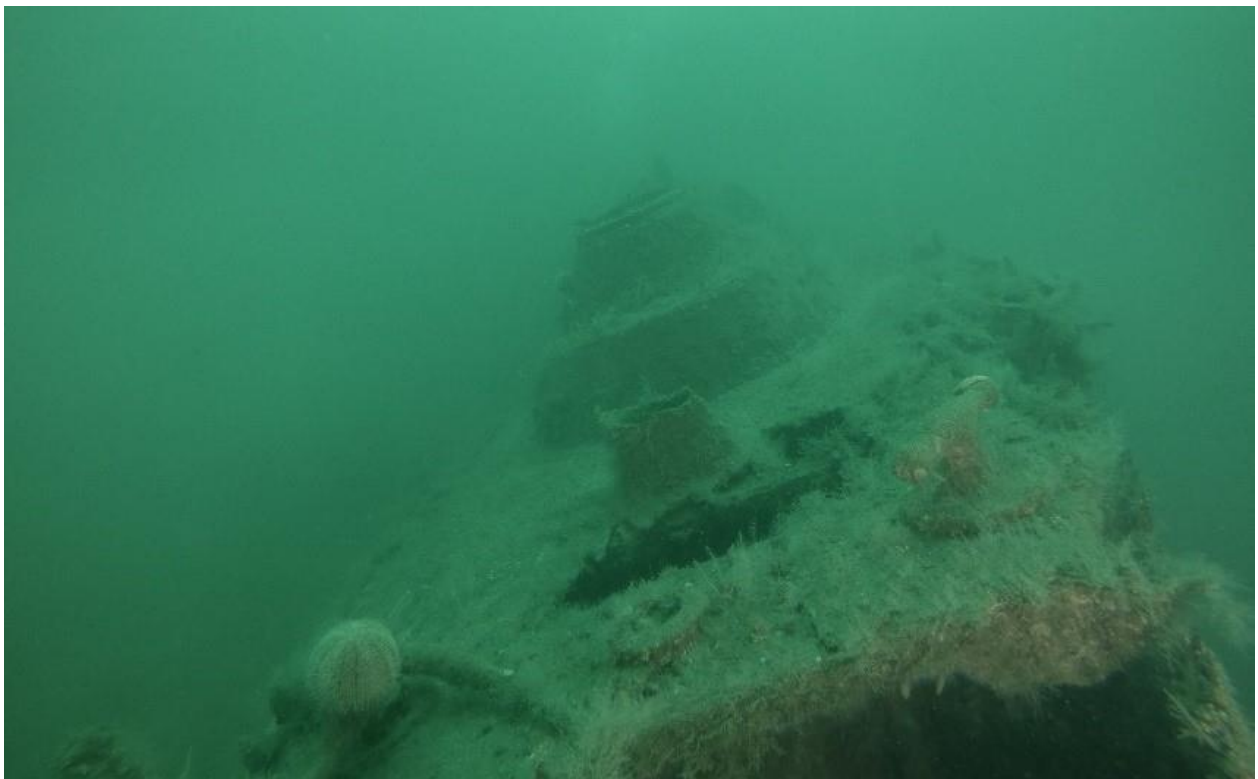
*Figure 11: Wreckage of small pinnace- type vessel lying to the south-west of HMS Royal Oak*

This anomaly represented a small wooden vessel of a pinnace or picket boat design. The wreck was lying upright in approximately 28m water depth. The bow section was well preserved. Records indicate that a steam picket boat drifted away from the *Royal Oak* carrying survivors from the torpedo attack, but subsequently capsized and sank as it was overloaded. It almost certain that the wreckage examined on this survey was the remains of that vessel.

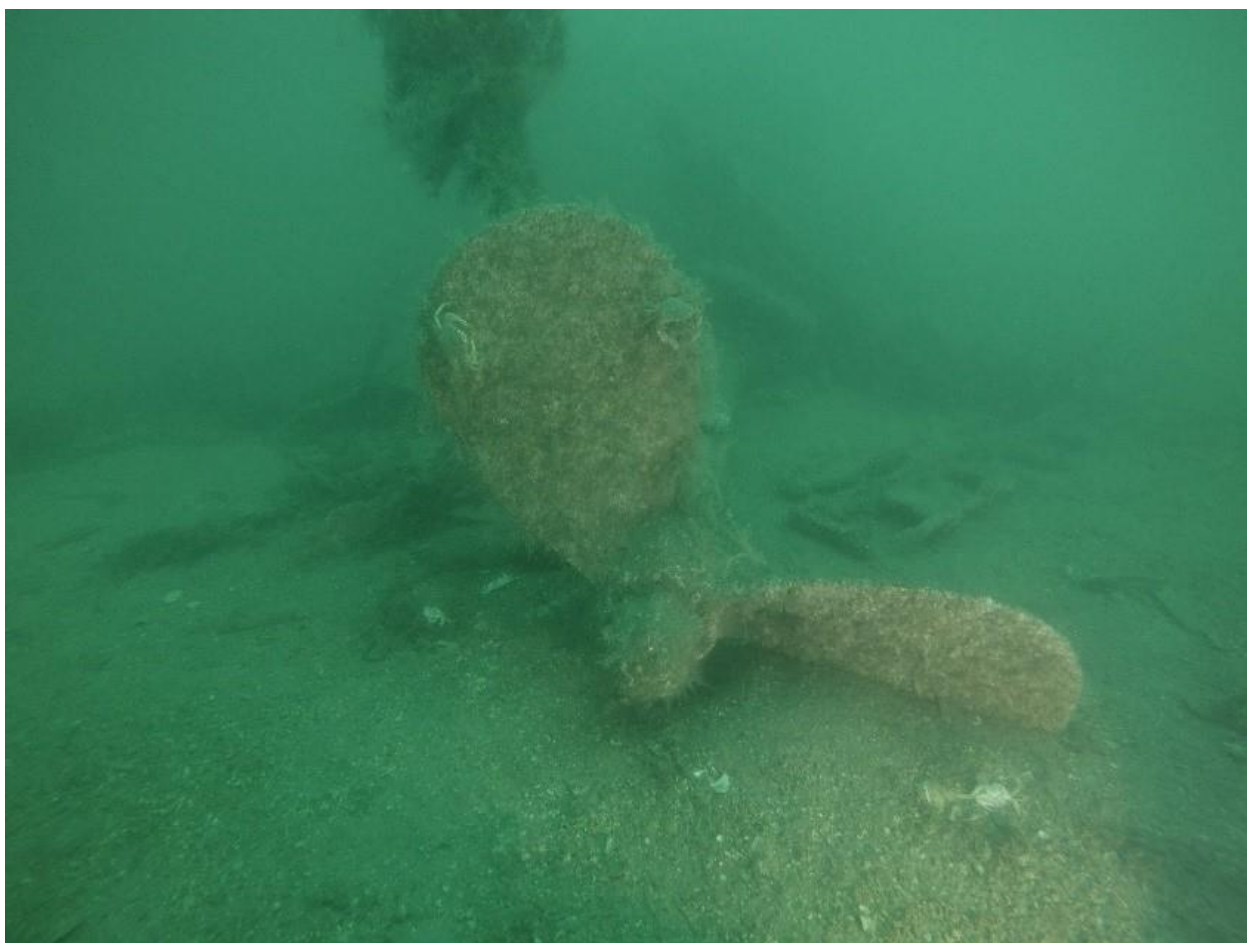
*Figure 12: Propeller of pinnace*

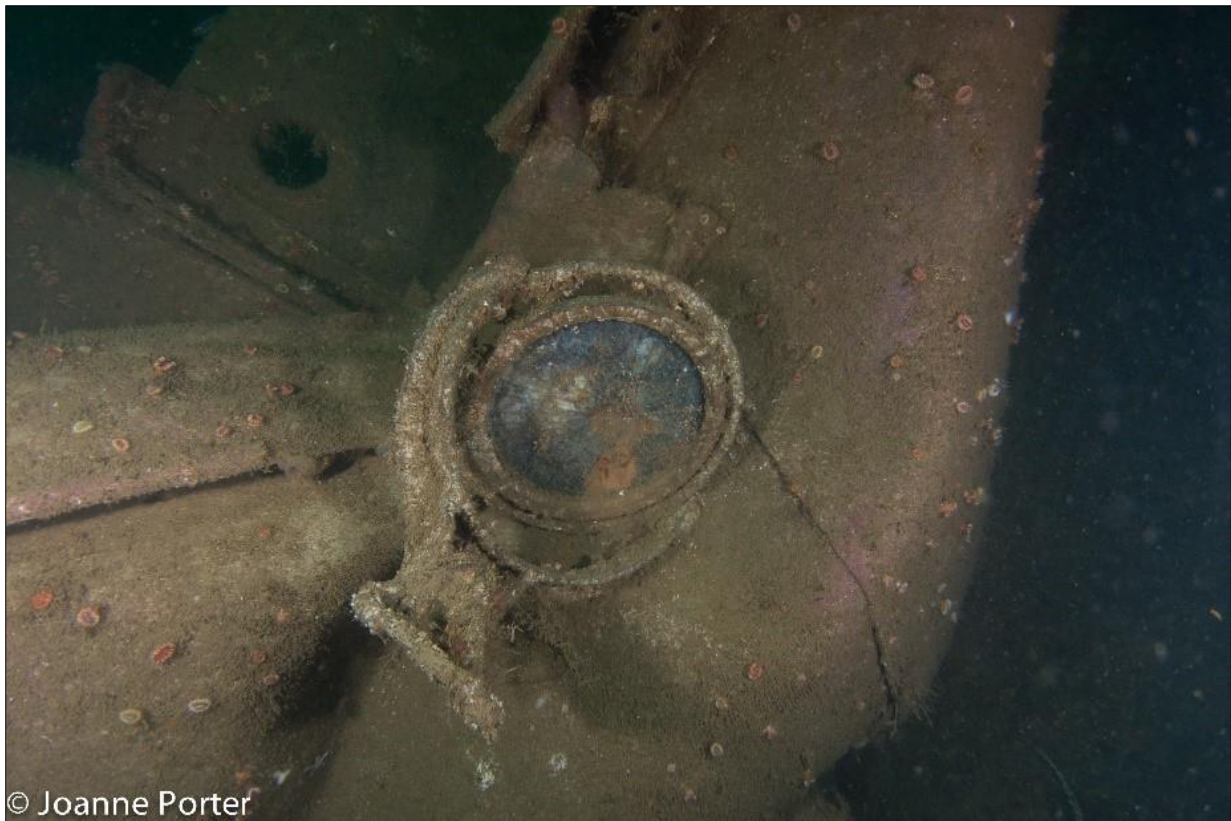
Figure 13: Compass remains HMS Royal Oak
