HISTORIC  
ENVIRONMENT  
SCOTLAND

## High Seas Fleet Salvage Sites Report

This report was compiled by ORCA Marine, University of the Highlands and Islands Archaeology Institute and SULA Diving on behalf of Historic Environment Scotland

9<sup>th</sup> January 2018

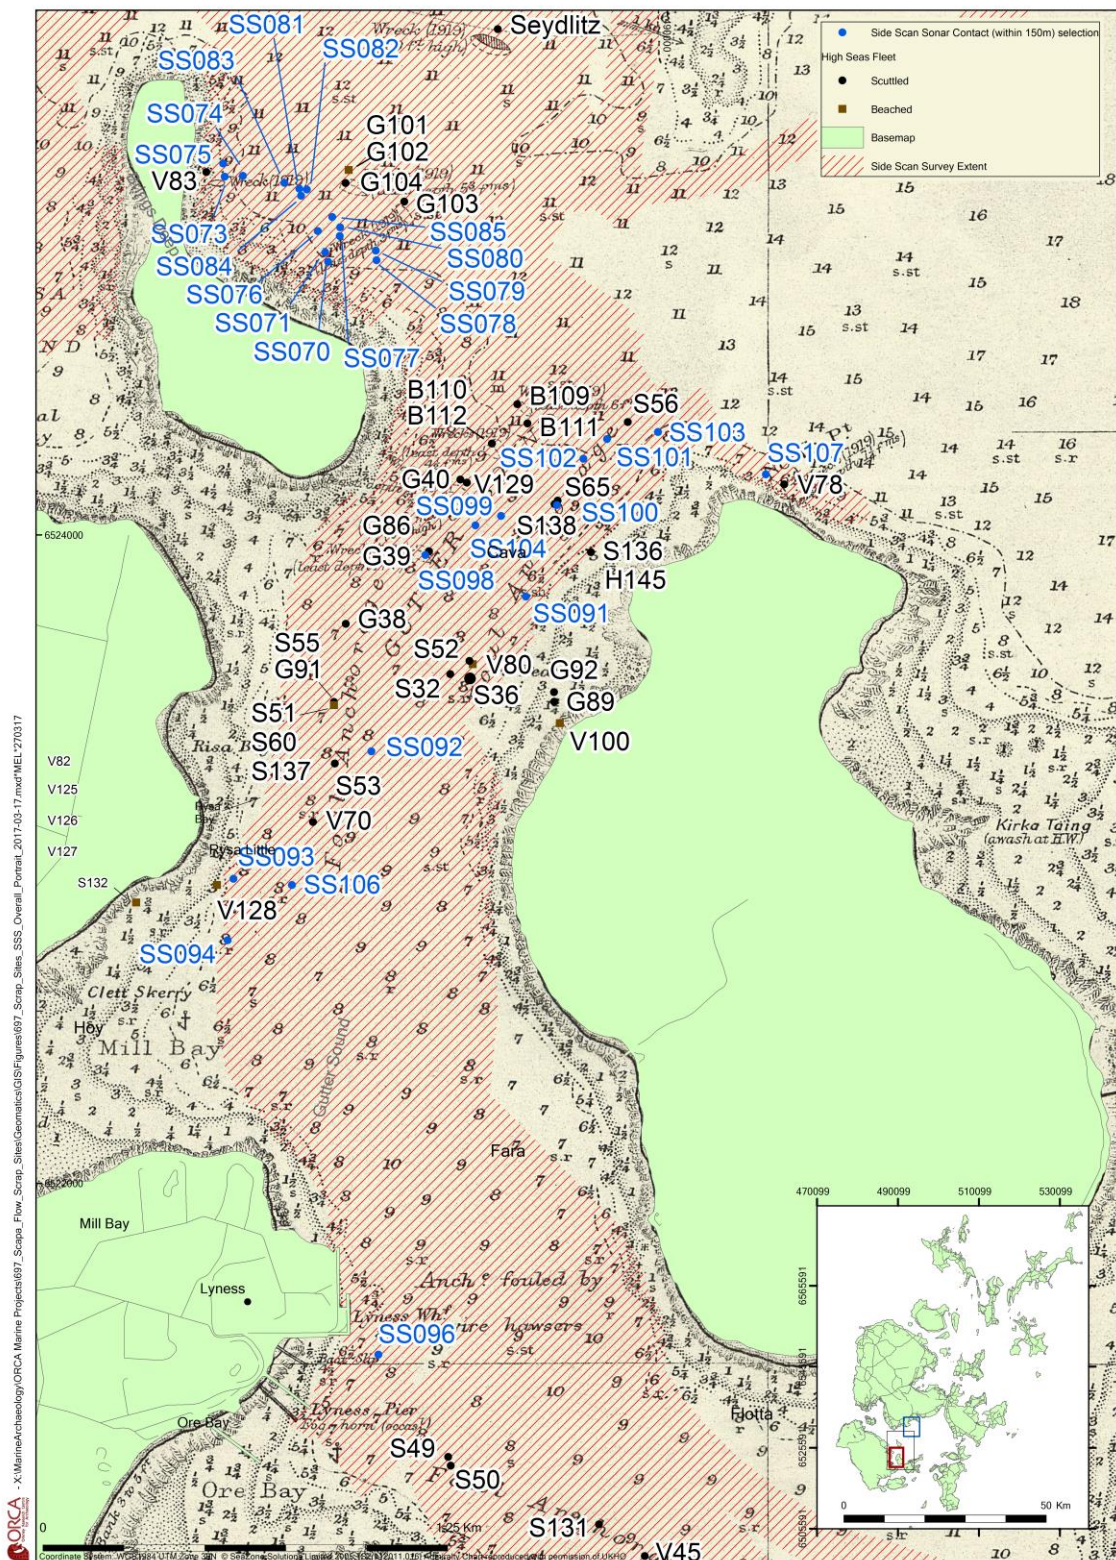
Figure 2 Side Scan Sonar Survey covering area of destroyer wreck sites or anchorages, all anomalies within 150m of a destroyer location are shown on the map.

The destroyers were predominantly anchored in Gutter Sound: the 1923 UKHO charts detail the position of the scuttled destroyers. This area was surveyed using side scan sonar survey, and geophysical anomalies were identified ([Figure 2](#)). There were sixteen anomalies identified in the destroyer survey area (see Appendix 1 for full description) within 150m of a known destroyer anchorage or scuttled location ([Figure 2](#)). The ground-truthing of contacts located at Rysa Little established that SS080 and SS085 are not materials associated with the destroyer salvage operations. The ground-truthing of the other contacts, potentially associated with destroyer remains, were out with the remit of this phase of work. The majority of destroyers were lifted upright with little or no removal of structural elements of the vessel, therefore only a few features of these salvaged ships are expected to exist on the seabed apart from such items as anchors. The greatest extent of submerged remains of the German High Seas Fleet destroyers are represented in Scapa Flow by wrecks such as *B109*, *S54* and *V83*, along with examples of the re-use of destroyers such as at the site of SMS *Hindenburg*, SMS *Seydlitz* or *S36* (see Appendix 2).

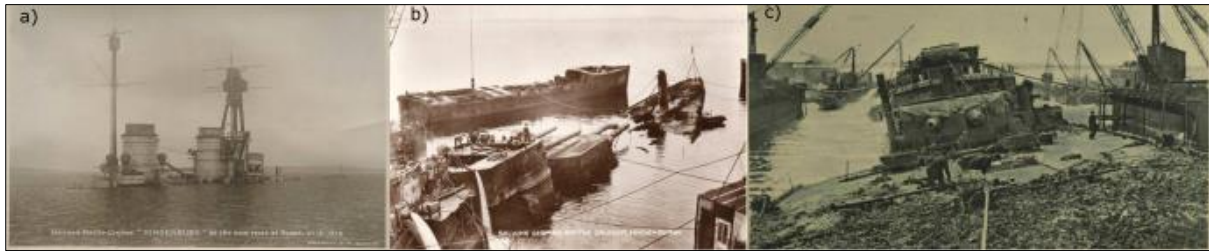
Plate 2 a) Postcard of the iconic image of the *Hindenburg* superstructure protruding above the water of Scapa Flow after the scuttling (courtesy Kevin Heath) b) Postcard of ongoing salvage operations on *Hindenburg*, destroyer in use as a barge visible in background (courtesy Kevin Heath) c) Image of workers clearing marine growth from the successfully salvaged *Hindenburg* (Illustrated London News)

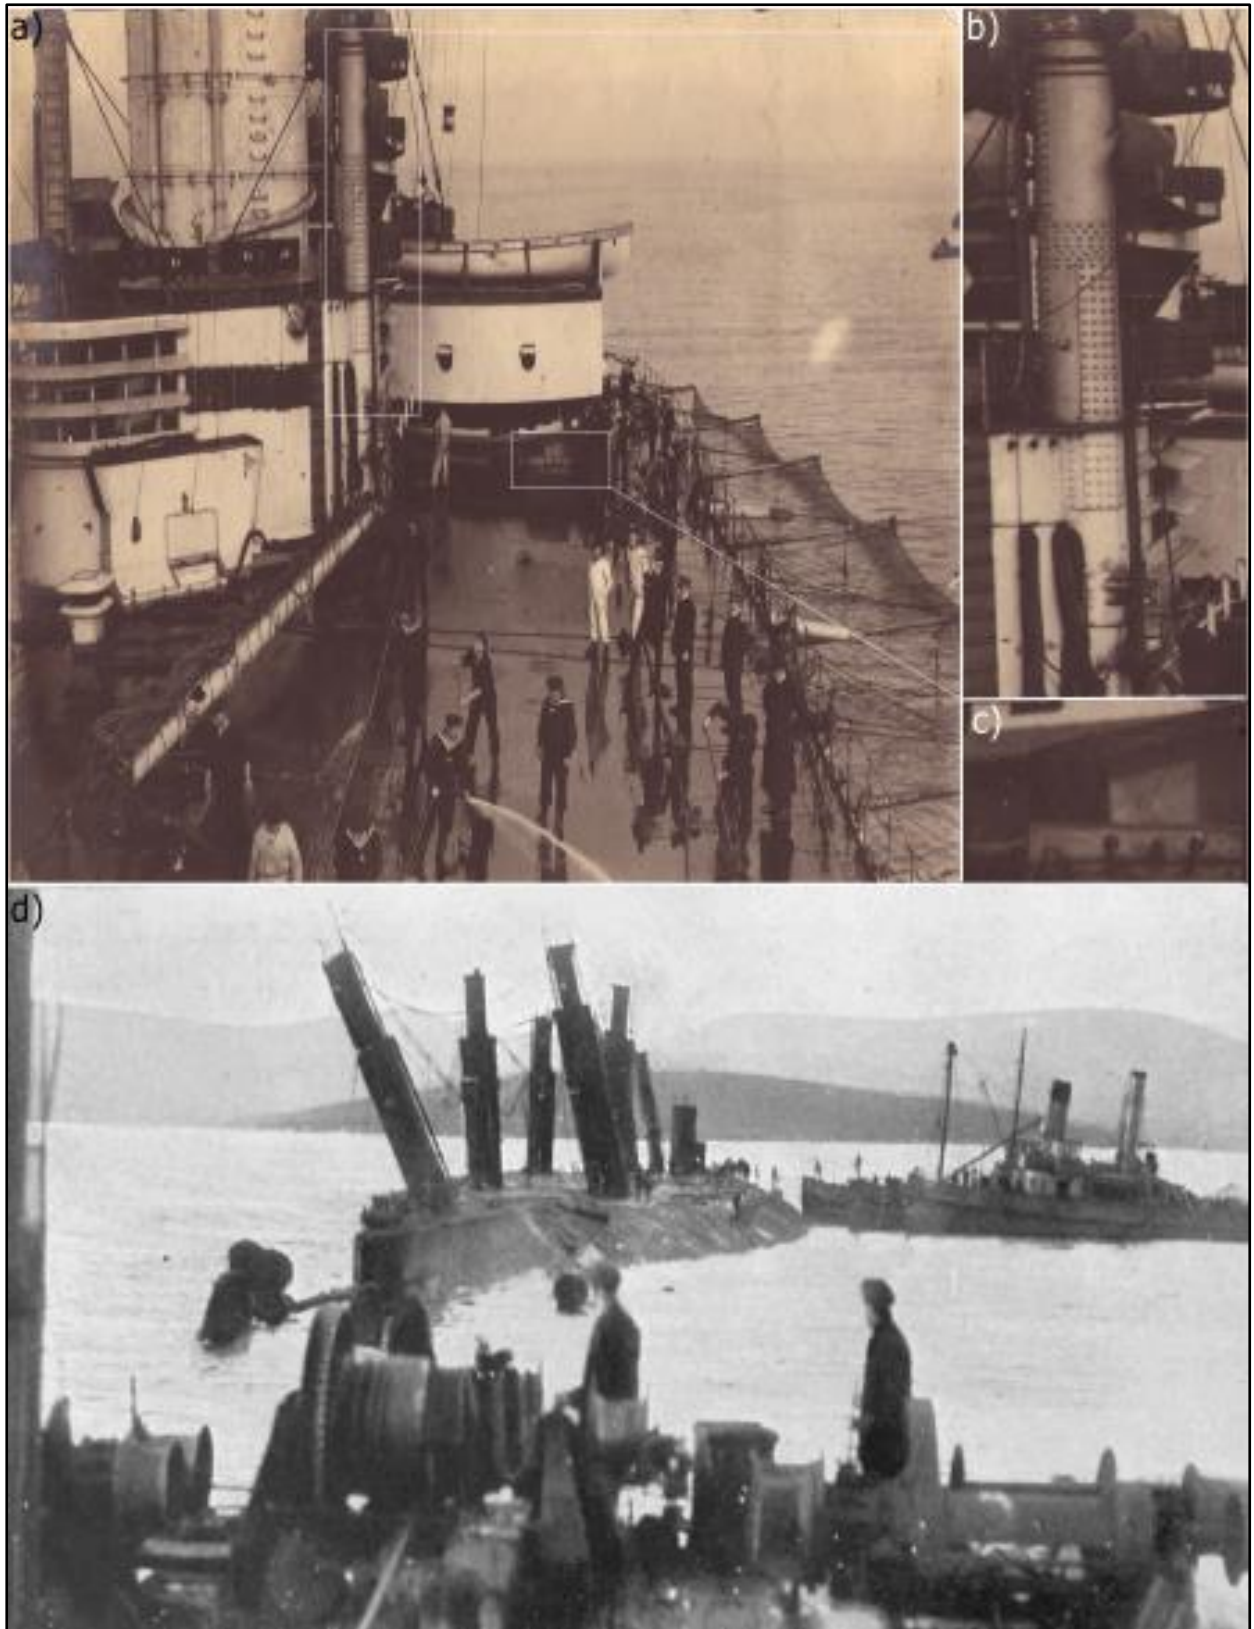
Plate 5 a) Von der Tann (courtesy Gary Staff) b) Riveted samson post c) rectangular storage boxes for sub calibre barrel liners under the gun turrets on Von der Tann d) Von der Tann after lifting, salvage vessel visible in the background (The Sphere 20<sup>th</sup> December 1930)

fitted each side of the upper deck on *Von der Tann* ([Plate 6](#)) (Friedman, 1992). The two rectangular boxes on this site are containers for sub calibre barrel liners; these were used for training to prevent wear on the gun barrels by firing a smaller round. Heavy wear on the ship's main armament when firing means that after approximately 150 rounds the gun liner needs replacement. This big operation involves returning the gun to the manufacturer. The use of these sub calibre gun liners would have been both time saving and cost effective. The rectangular containers had hatches at each end to facilitate cleaning of the barrel without removing it from the box. The two holes in the back of the gun turret were used to insert the sub calibre tubes. The holes line up exactly with the 28 cm gun barrels inside the turret. This type of rectangular sub calibre storage box is rare, and largely unknown as most were cylindrical in shape ([Plate 5a; 5c](#)) (*per com* Marsden Samuel).

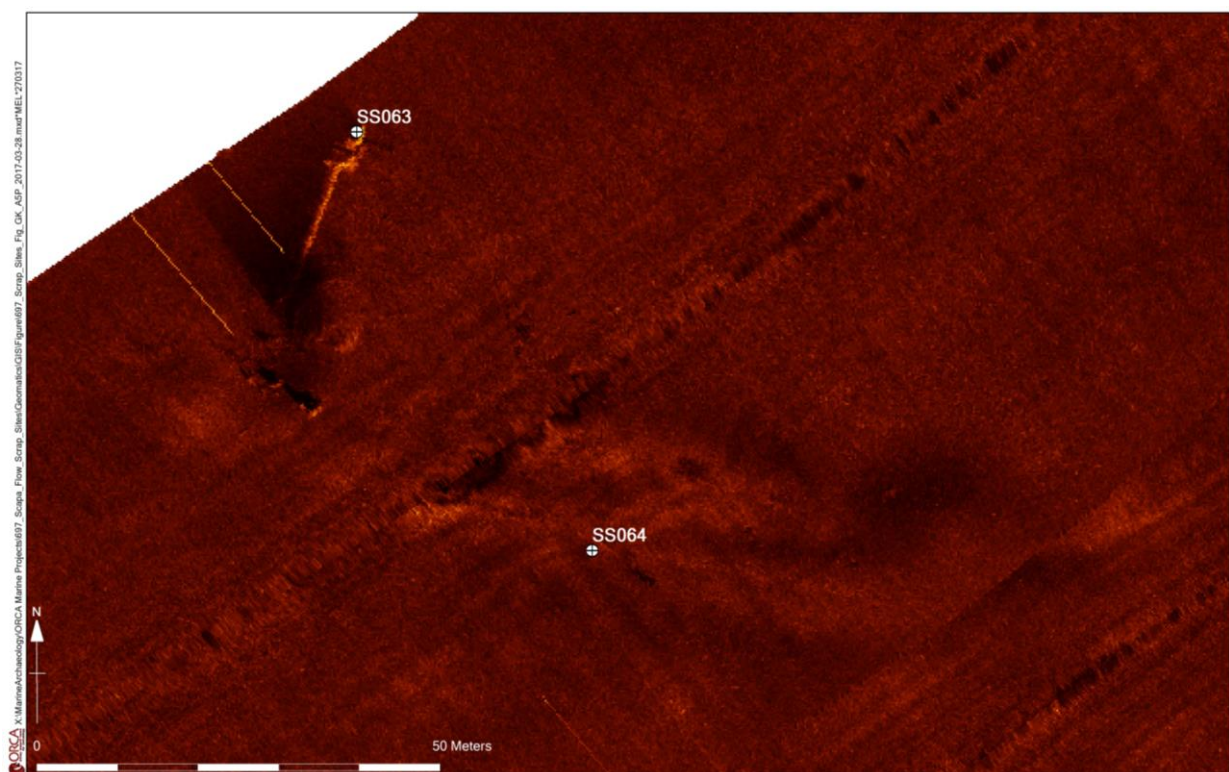
Figure 5 Primary site of the *Grosser Kurfürst* where she sat on the seabed in Scapa Flow until she was lifted by Metal Industries Ltd.

The side scan sonar survey of *Grosser Kurfürst* collected medium frequency data (325KHz) and focused high frequency data (780kHz). This provided an overview of the final scuttled location and salvage area of the battleship. Anomalies SS063 & SS064 (see Appendix 1) were identified as associated with the salvage operations on the *Grosser Kurfürst* at her primary site.

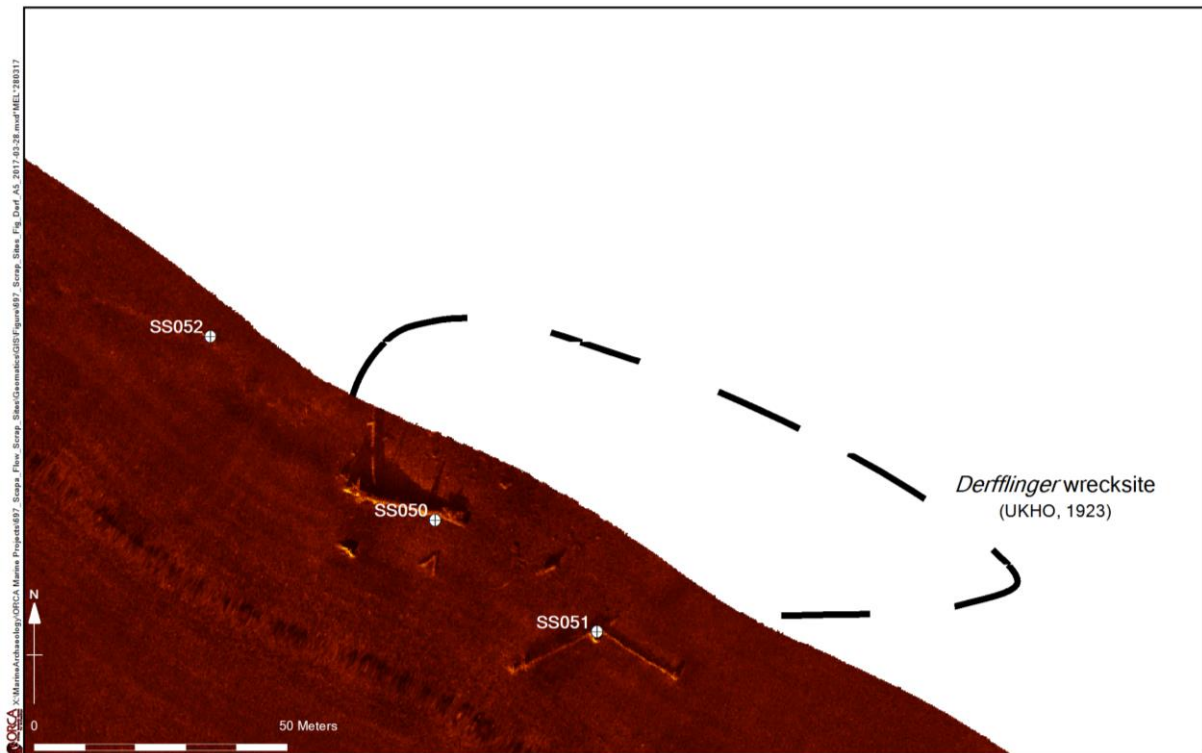
Figure 6 Primary site of the *Derfflinger*

The side scan sonar survey of *Derfflinger* collected medium frequency data (325KHz) and focused high frequency data (780kHz). This provided an overview of the final scuttled location and salvage areas of the battleship. Anomalies SS050, SS051 & SS052 (see Appendix 1) were identified as associated with the salvage operations on the *Derfflinger* at her primary site.

Swannay (1996) describes the site as consisting of two pinnacle diesel engines, masts, spotting tops, searchlights and deep scour. These anomalies were not dived during this phase of work. The sonar survey at Rysa Little identified a number of anomalies that may represent remains of the *Derfflinger* at her secondary site (see [Rysa Little Secondary Sites](#)).

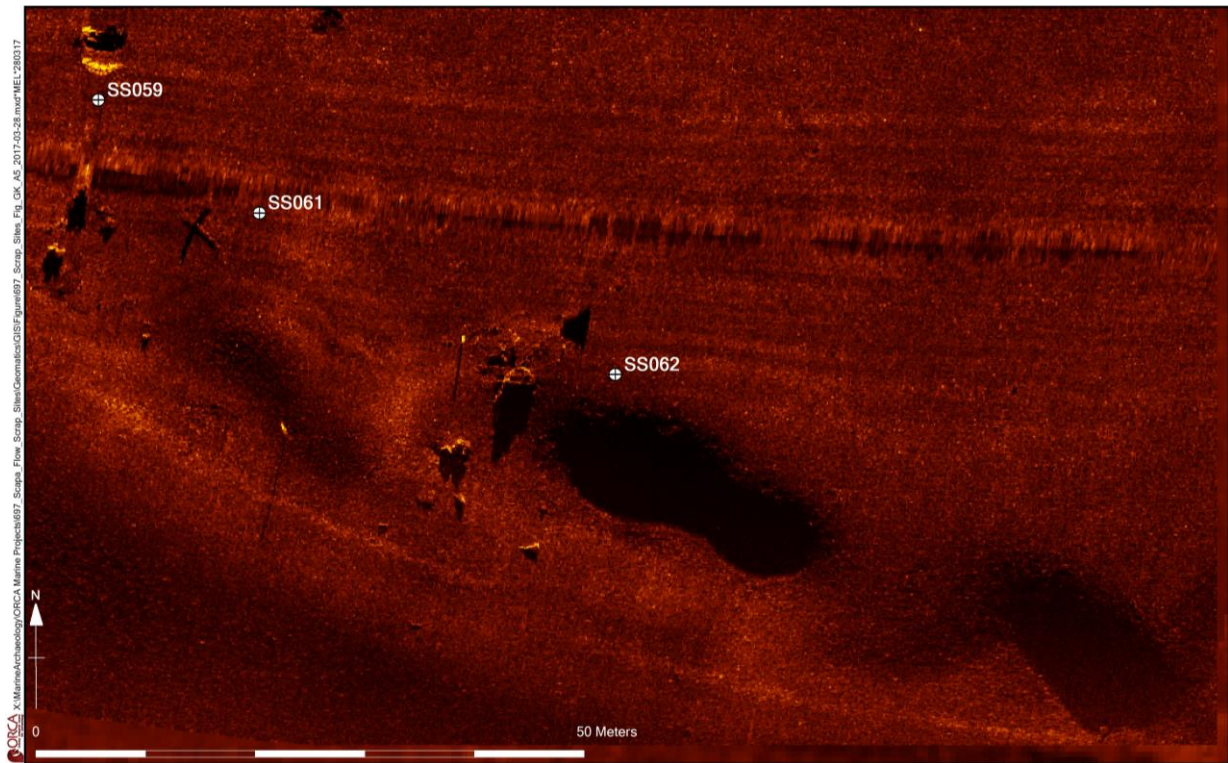
Figure 7 Primary site of *Friedrich der Grosse*

The side scan sonar survey of *Friedrich der Grosse* collected medium frequency data (325KHz) and focused high frequency data (780kHz). This provided an overview of the final scuttled location and salvage areas of the battleship. Anomalies SS059, SS060, SS061 & SS062 (see Appendix 1) were identified as associated with the salvage operations on the *Friedrich der Grosse* at her primary site. These anomalies were not dived during this phase of work.

Swannay (1996) describes the site as being scoured out, consisting of a pinnacle, mast and searchlights. The sonar survey at Rysa Little identified a number of anomalies that may represent remains of the *Friedrich der Grosse* at her secondary site. Smith (1989) states that the bell of *Friedrich der Grosse* was recovered from one of the scrap sites at Rysa Little in 1984 by the Golden Lion Sub Aqua Club of Wrexham. The bell is now in Stromness museum.

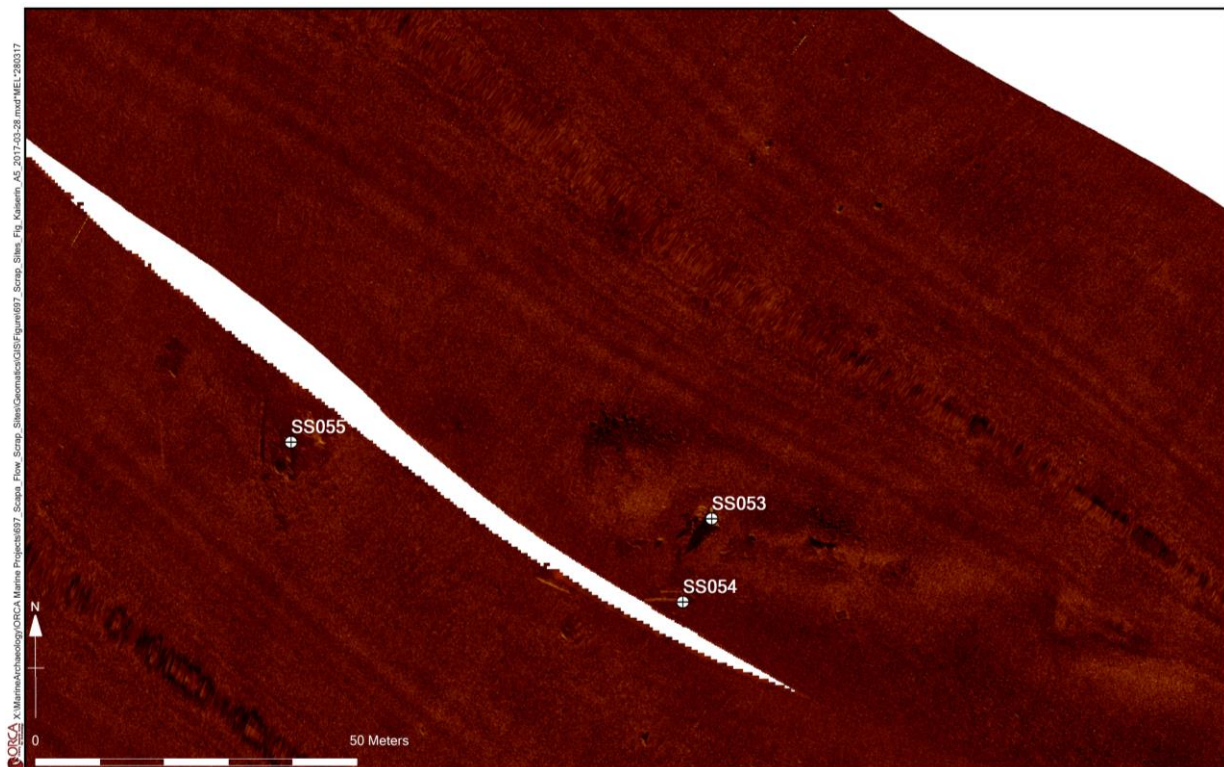
Figure 8 Primary Site of the *Kaiserin*

The side scan sonar survey of *Kaiserin* collected medium frequency data (325KHz) and focused high frequency data (780kHz). This provided an overview of the final scuttled location and salvage areas of the battleship. Anomalies SS053, SS054 & SS055 (see Appendix 1) were identified as associated with the salvage operations on the *Kaiserin* at her primary site. These anomalies were not dived during this phase of work. Swannay (1996) describes the site as a double scour with pinnacle and masts. The sonar survey at Rysa Little identified a number of

anomalies that may represent remains of the *Kaiserin* at her secondary site (see [Rysa Little Secondary Sites](#)).
