## **Wreck of the Edindoune (BF1118), Scapa Flow, Orkney.**

### **Final Report**

**Submitted to:** Historic Environment Scotland

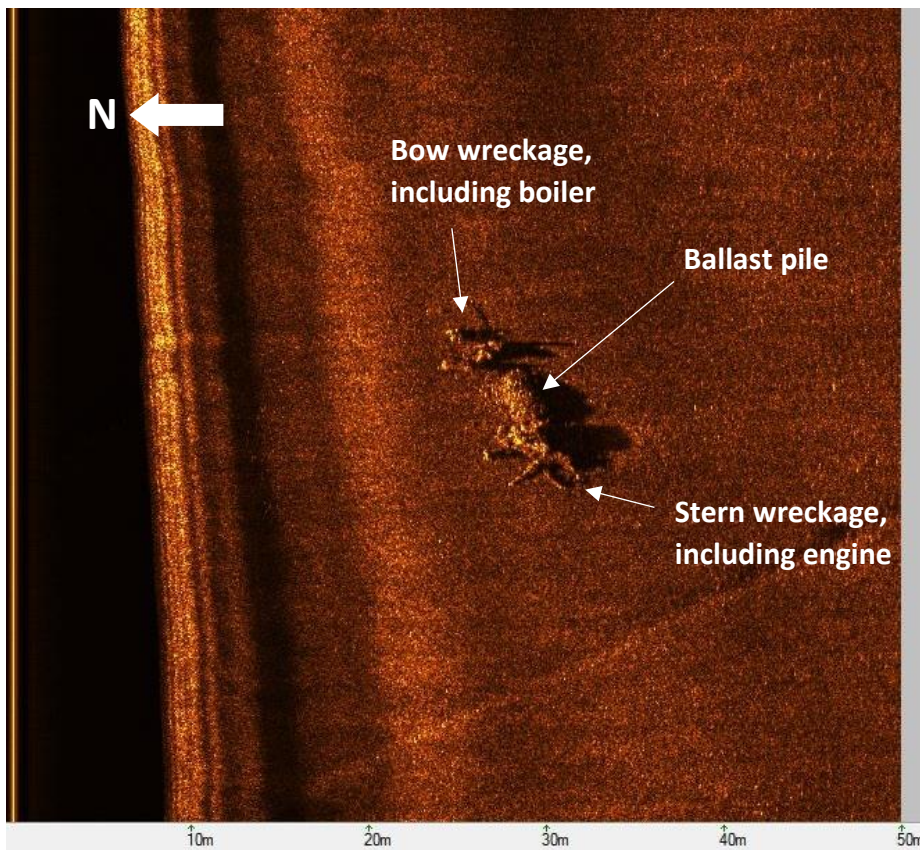
Consequently, the original survey images collected in January 2016 and again in June 2016, were used as an illustration of the site extent and to inform the dive survey. The sonar picture collected in June 2016 (Figure 3) shows a site of approximately 22m long, oriented on a southwest-northeast axis. The initial drop camera footage revealed a ballast pile that is most likely that middle portion of the sonar image with stern wreckage (including engine) to the southwest and additional wreckage, including a boiler, to the northeast. Water depth at the site was approximately 32m on a level seabed composed of a mixed mud/sand/gravel substrate.

Figure 3: Sonar image of the site collected in June 2016 using medium frequency (325 kHz) in June 2016. Features noted from the drop camera survey are shown.

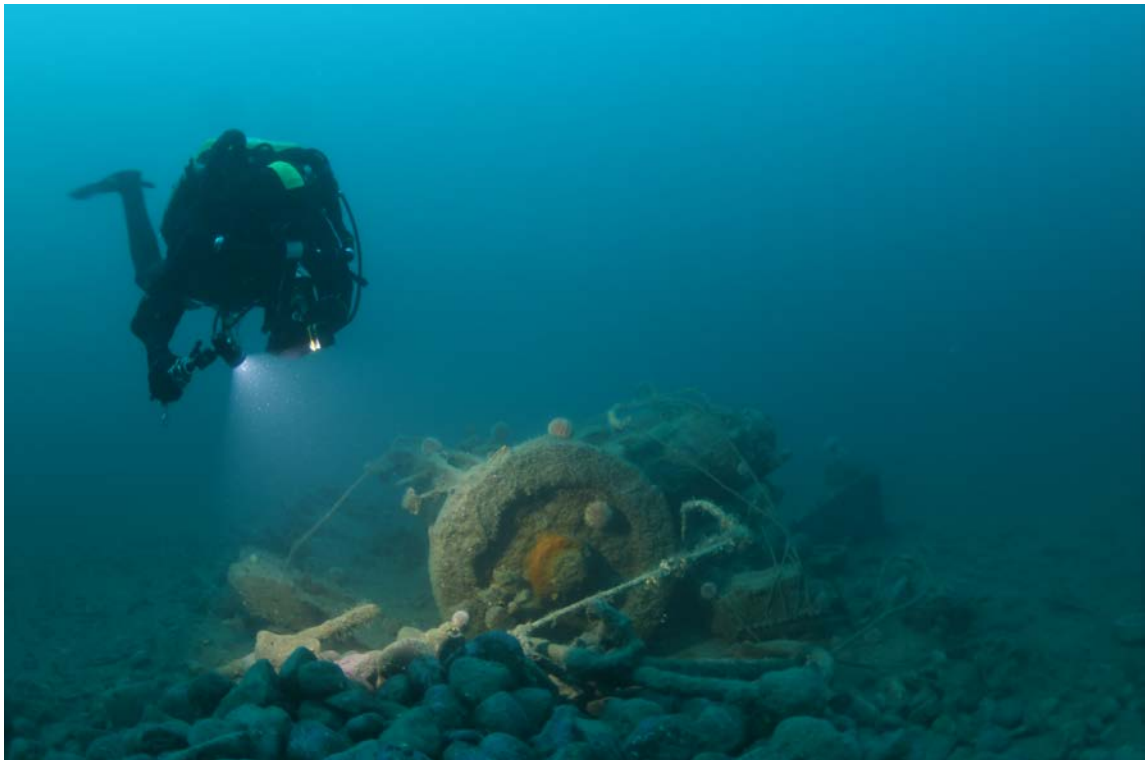
*Figure 9: Looking aft over the ballast pile towards the engine.*

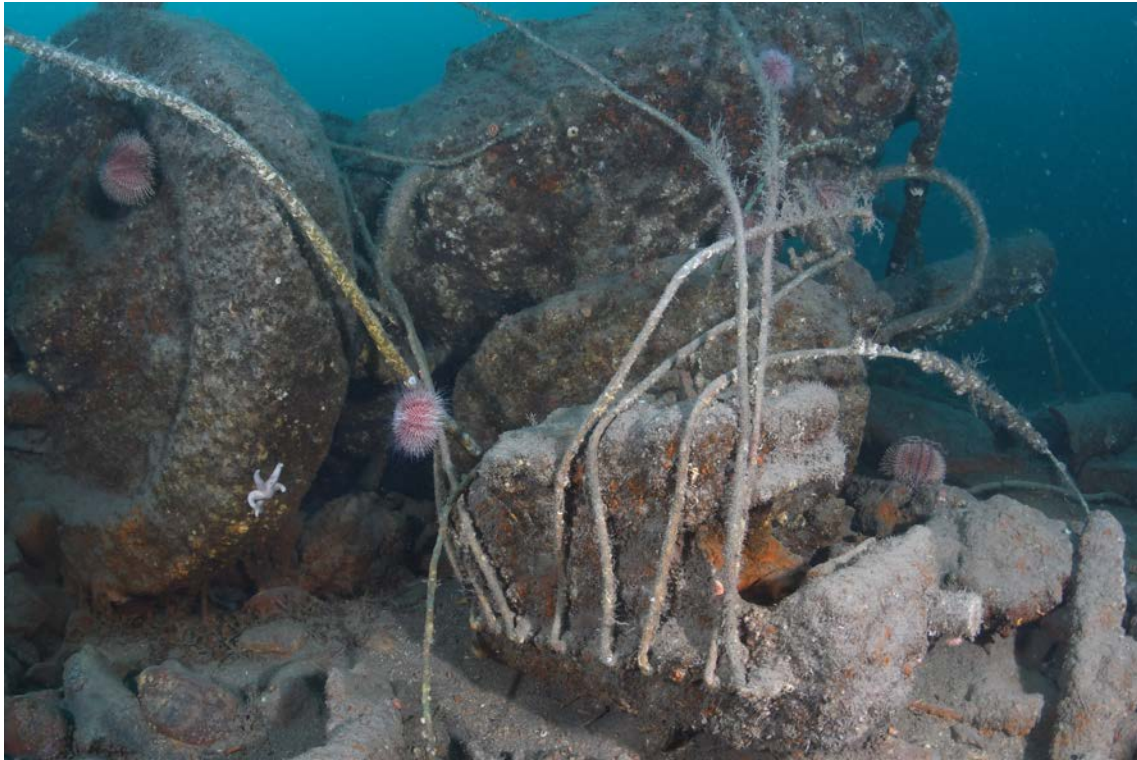
*Figure 12: Engine with automatic oiler box box and pipe work in foreground.*

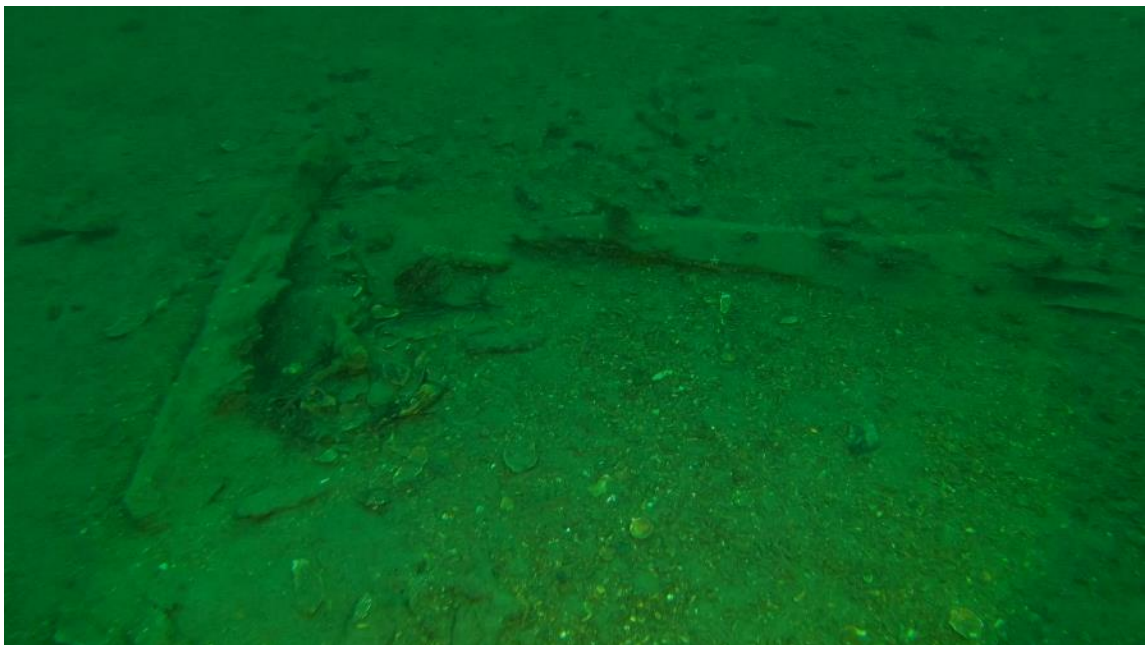
- Heavy timber (Figures 16 & 17). A heavy timber ran forward from the ballast pile and was mostly buried with only its top surface evident. Copper nail heads were protruding from the top surface of the timber. Its size and orientation (running aft under ballast pile and in line with the concrete ballast under the engine) suggested that this was the keel timber. A smaller section of timber lay off the front end that may have been the bow stem.

*Figure 17: Forward end of timber and possible bow stem to left of image.*

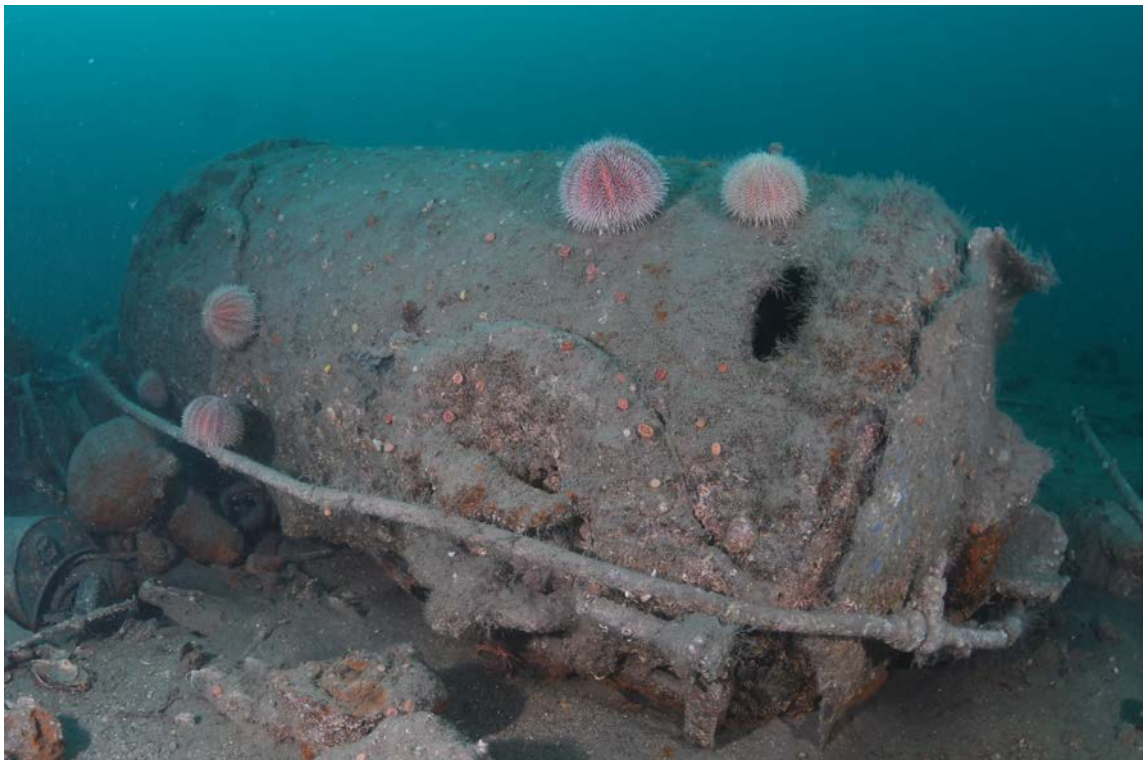
- Boiler & capstan winch (Figures 18-20). These were located forward of the ballast pile. The boiler, which was lying on its side, was 1.6m in length and 0.7m in diameter. A hole on one end was most likely for its funnel (not seen) which together with the location of the stoking hatch suggested that it was installed in a vertical orientation. The remains of timber sheathing were evident on the outside of the boiler. The capstan winch was of the classic herring drifter design and was most likely made of cast iron. A large amount of copper pipework was also found associated with the boiler and capstan.

*Figure 19: Boiler and associated pipework.*

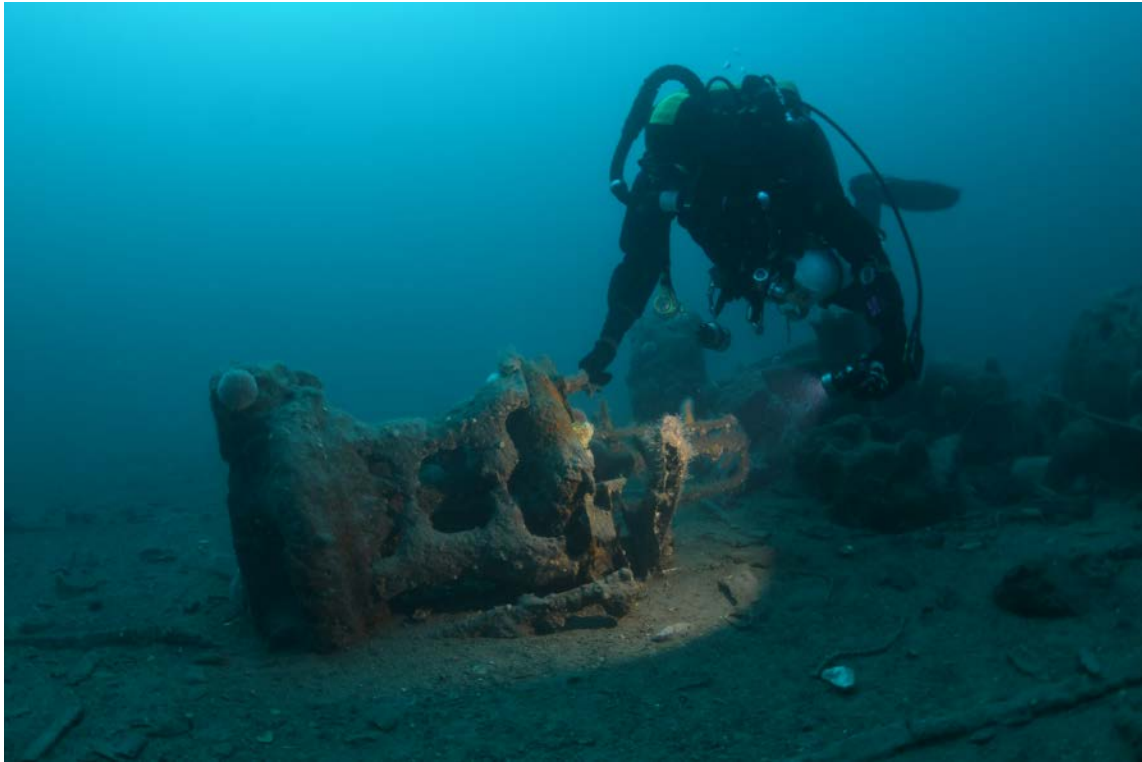
*Figure 20: Capstan winch typical of herring drifters.*

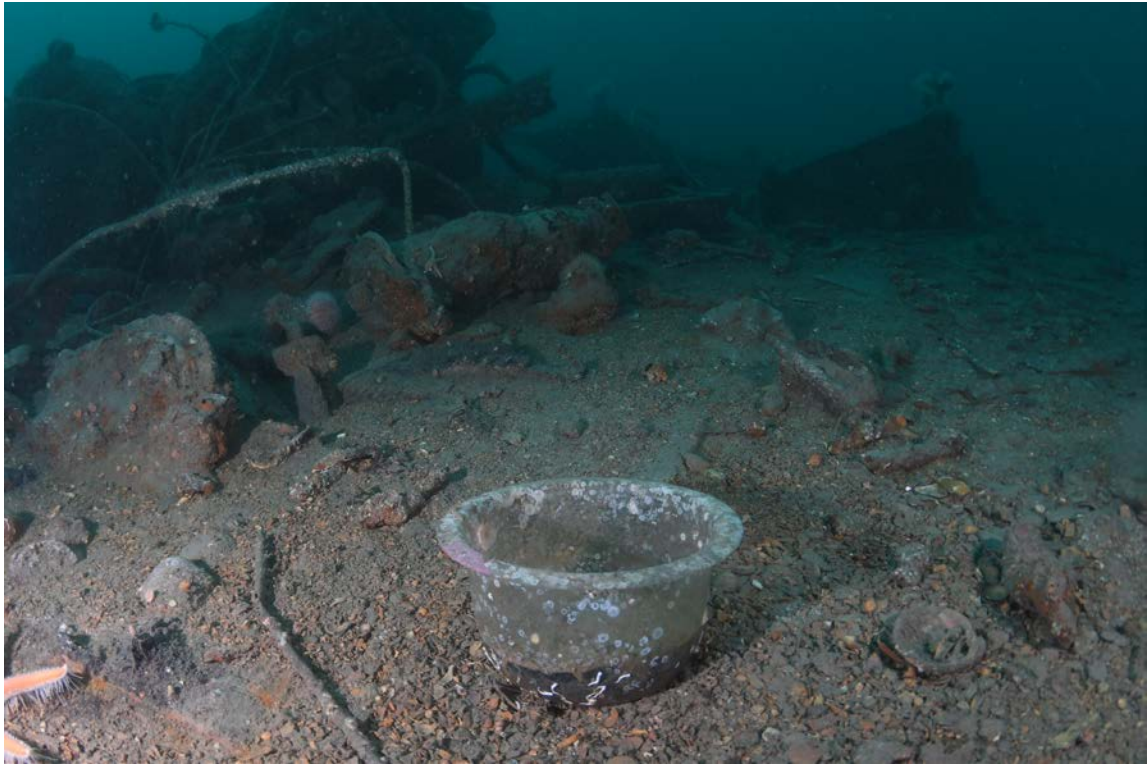
- Various china cups and plates;
  - A glass cover, function unknown, possibly a compass housing (Figure 22);
  - A copper saddle tank associated with the boiler (Figure 23); and

*Figure 22: Glass cover, function unknown, possible from a compass housing.*

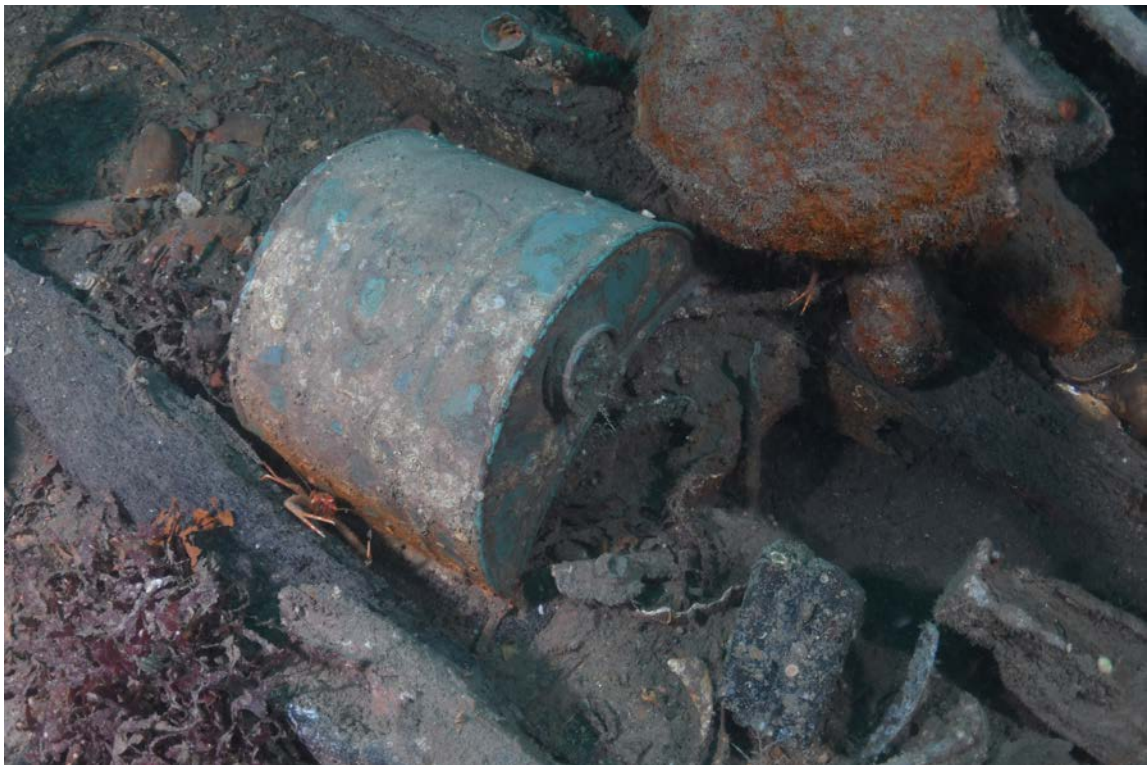
*Figure 23: Copper saddle tank among boiler pipework.*

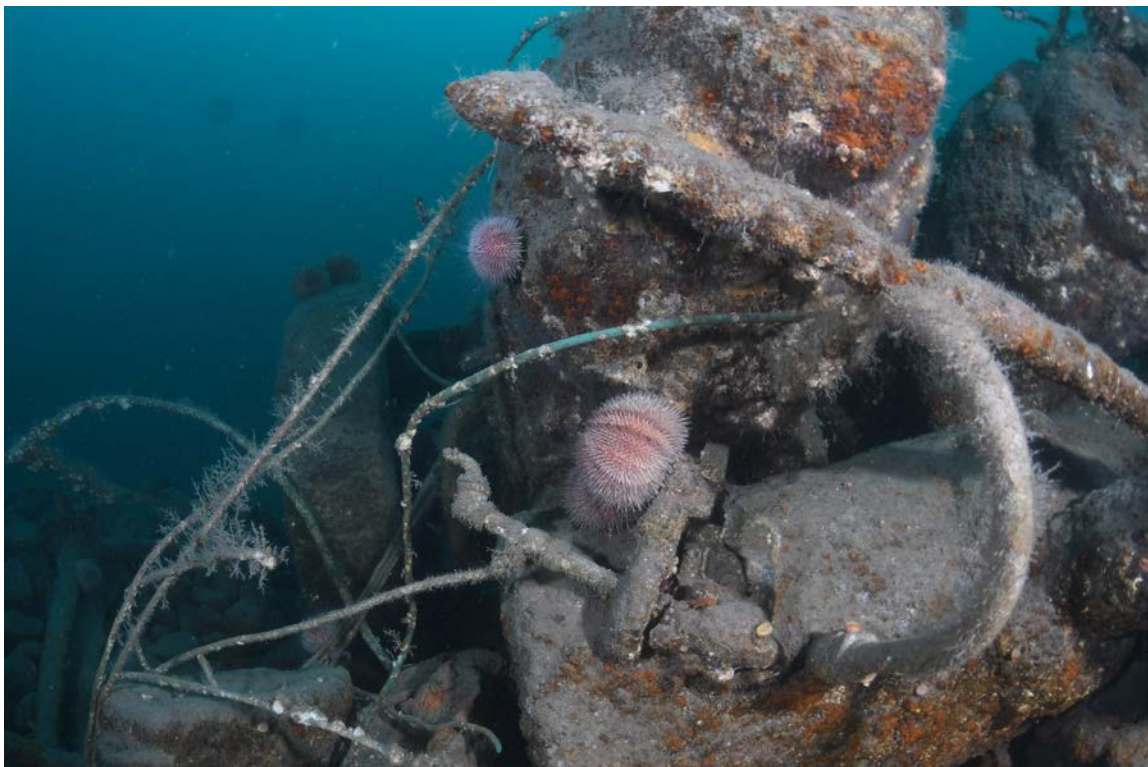
*Figure 25: Engine pipework.*

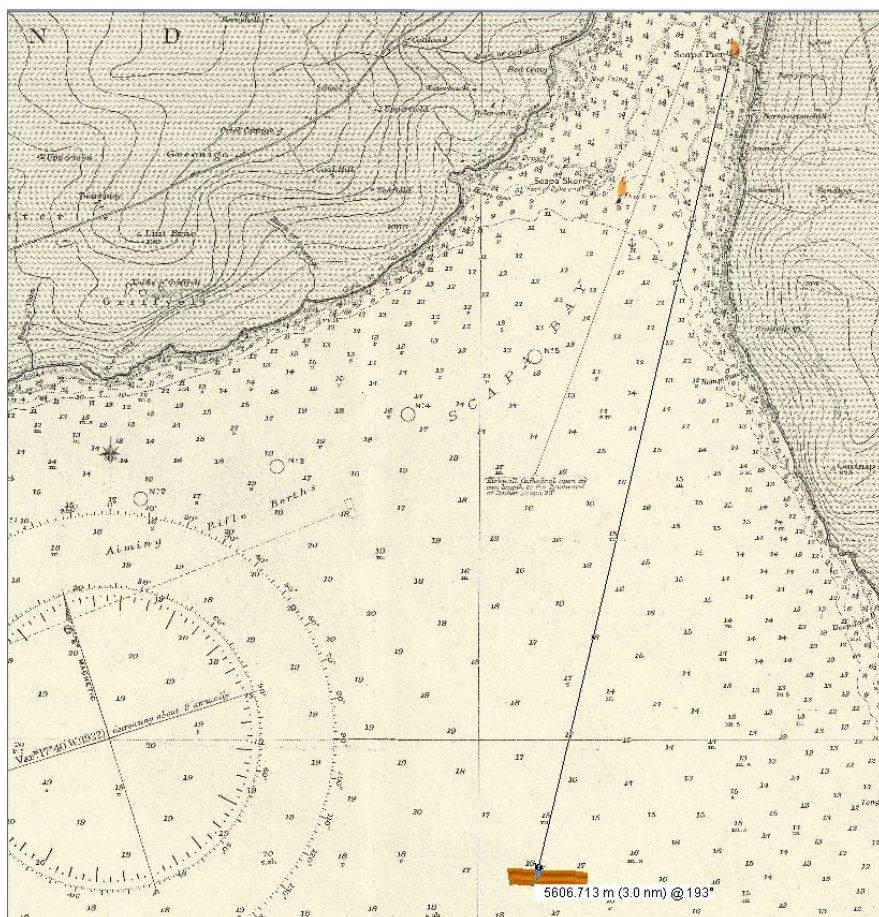
Figure 26: Location of wreckage as measured from Scapa pier, showing it to be exactly 3 nautical miles on a present bearing of 193° (T).

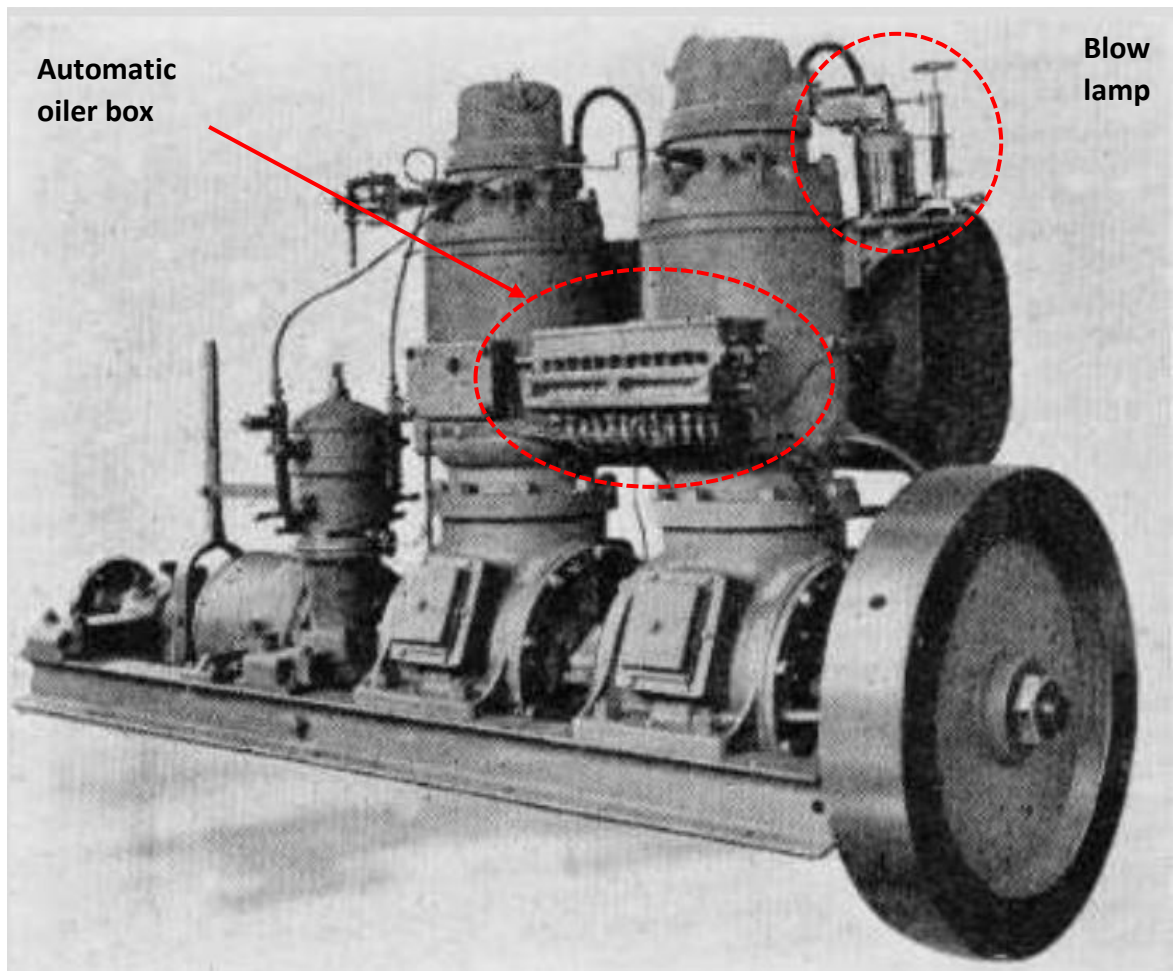
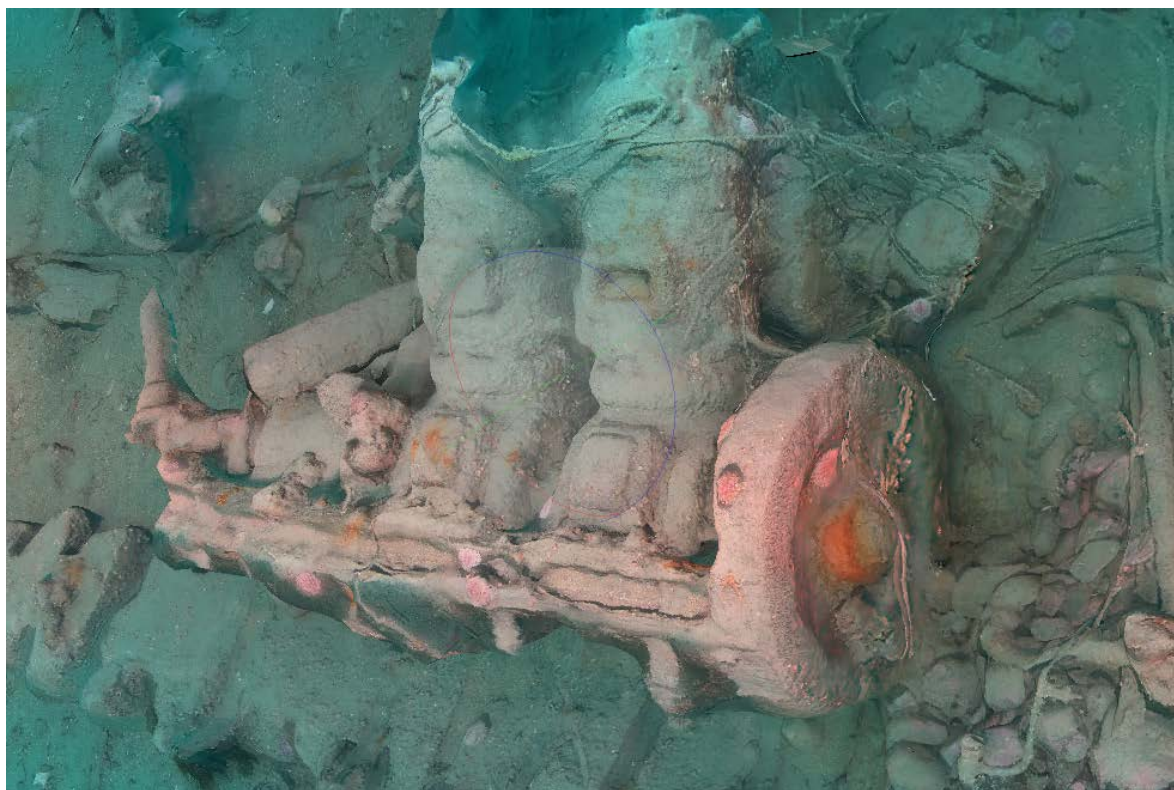
Figure 28: Woodward 2-cylinder hot bulb engine (top) compared to a photogrammetric image of the engine on the wreck (bottom). The automatic oiler and blow lamp are circled in the top image.
